# *Engine Accident Cases*

Mitsui O.S.K. Lines  
Marine Engineering Group  
Marine Division

Published June 2001

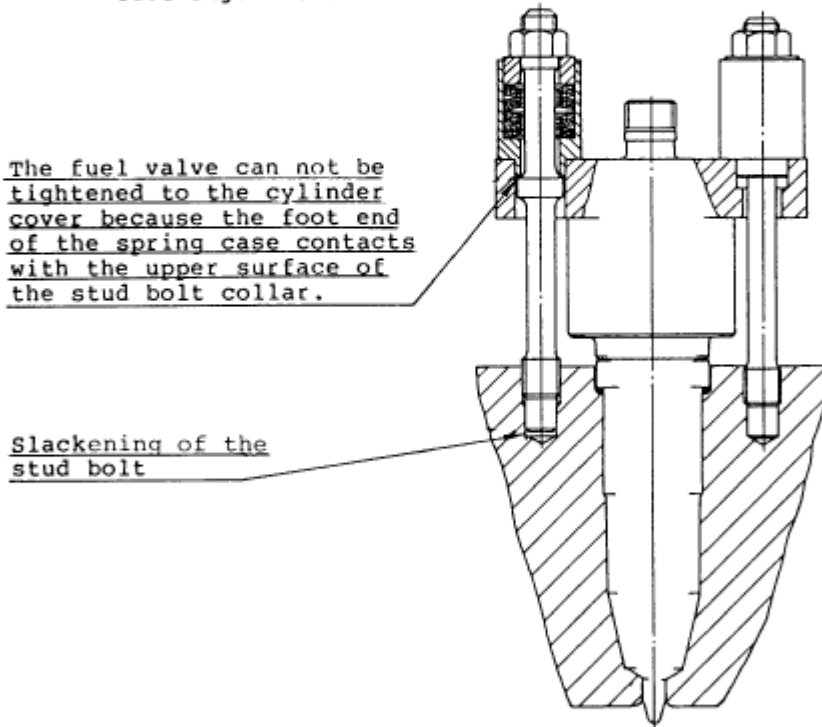
Accordingly, the oil tightness in the fuel valve could not be kept in order, resulting in the trouble of no fuel injection.

Fig.2 In case of the stud bolt slackened

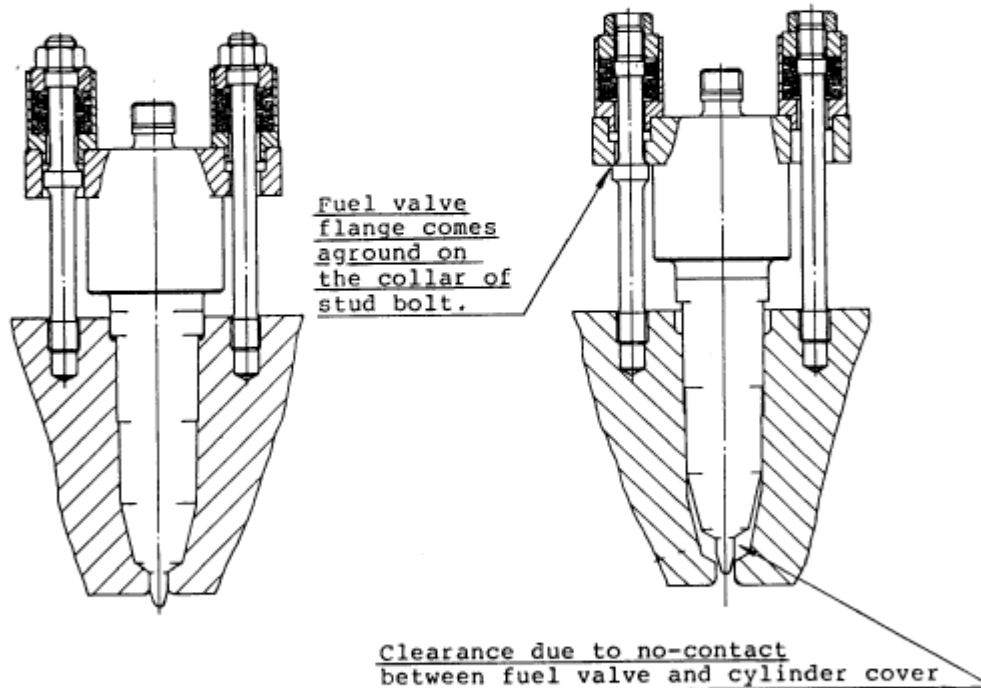
Wrong fitting direction

Fig.3 Fitting direction of the fuel valve

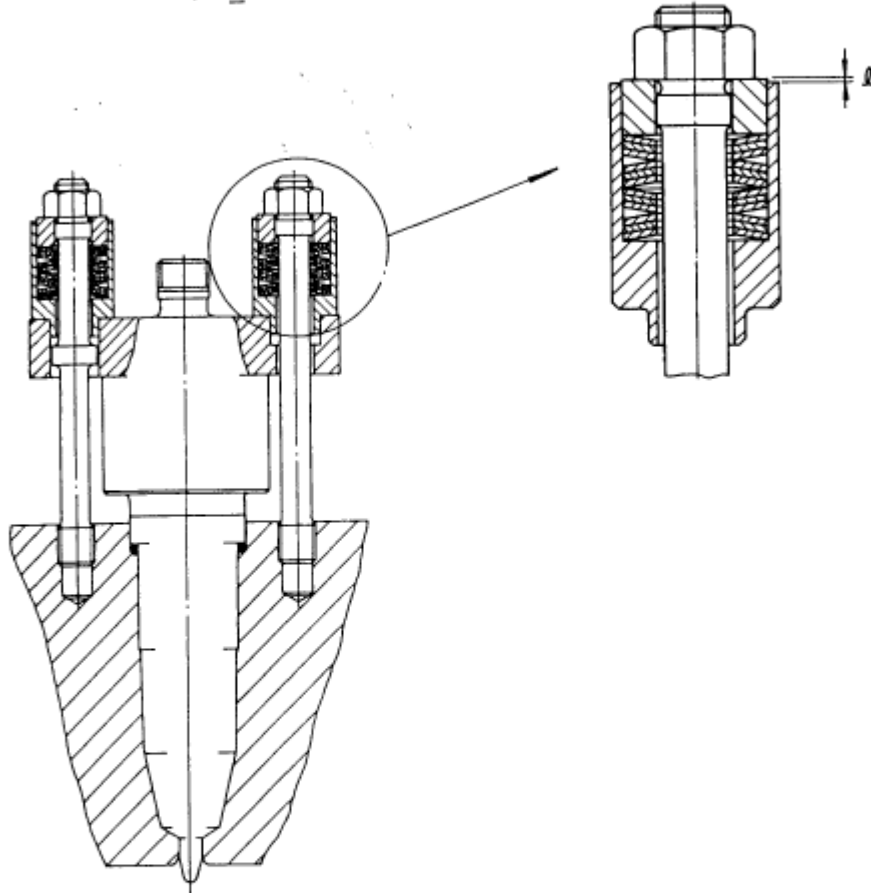
Before tightening of the fuel valve  $l = 2.4 \pm 0.2$  mm

After tightening of the fuel valve  $l = 0 \pm 0.2$  mm

The fuel valve body is tightened in the cylinder cover through the disk springs which are designed so that decreasing of the tightening force due to unavoidable deformation of each part or contacting each other can be minimized as far as possible. Please tighten the nuts so that the dimension " $l$ " becomes  $(0 \pm 0.2)$  mm.

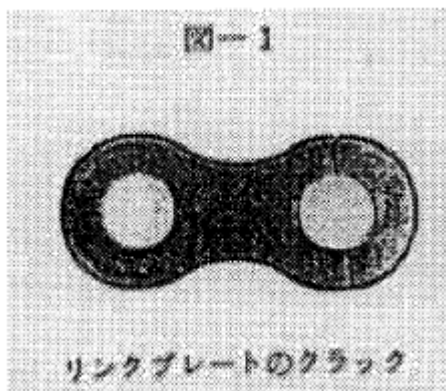
Fig. 1 Crack of the link plate

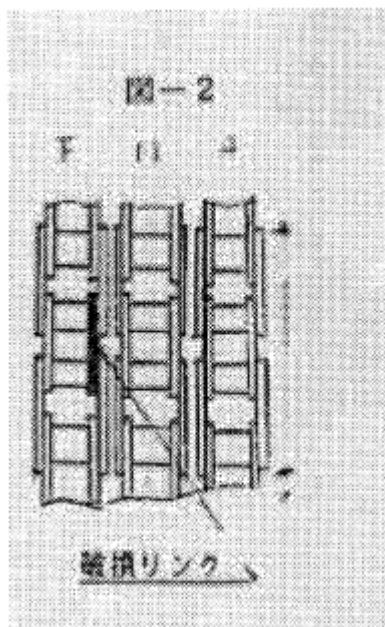
Fig.2 Damaged link
