# ITALIAN MARITIME INVESTIGATIVE BODY ON MARINE ACCIDENTS

MARINE ACCIDENT  
INVESTIGATION  
C/S COSTA CONCORDIA  
13<sup>th</sup> January 2012

*MSC90*  
*London - May 18<sup>th</sup>, 2012*

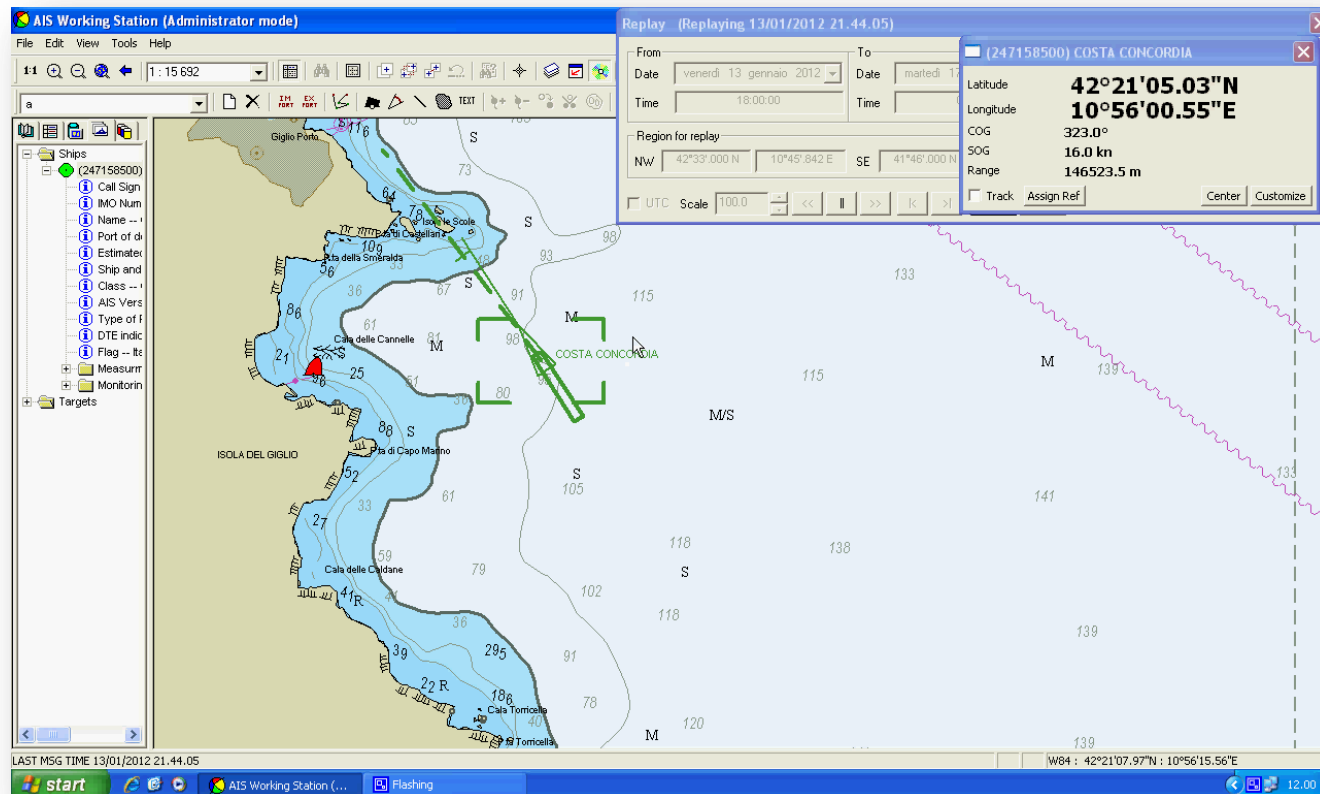
**09.44 pm**

- Manoeuvre still ongoing
- Ship's position:  $42^{\circ}21'05''\text{N}$ ;  $010^{\circ}56' \text{E}$   
her bow heading to "Le Scole Reef" - 0,3 miles off the rocks
- Speed: 16 knots

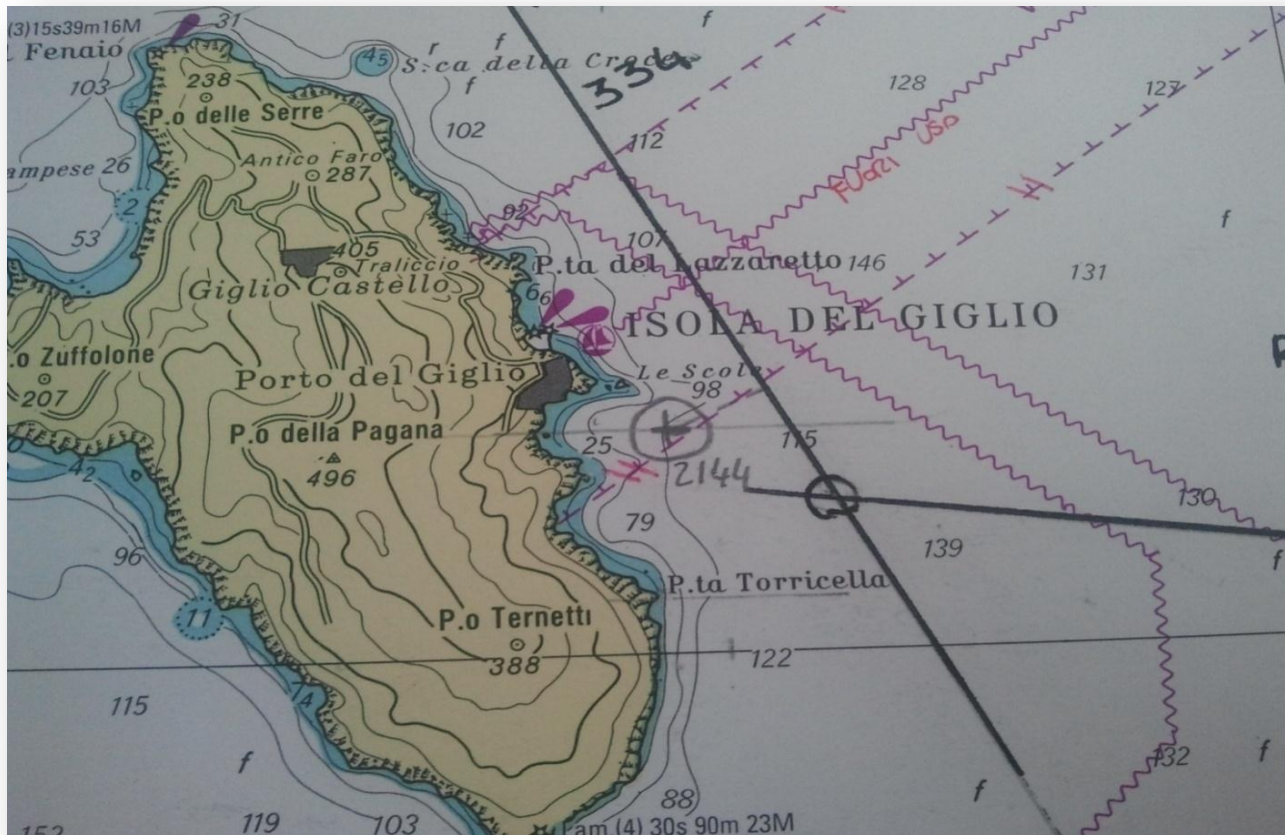
The Yaw Radius is such that the Ship is situated 0.5 miles south-west off the planned course - much more close to the coast compared to the planned route

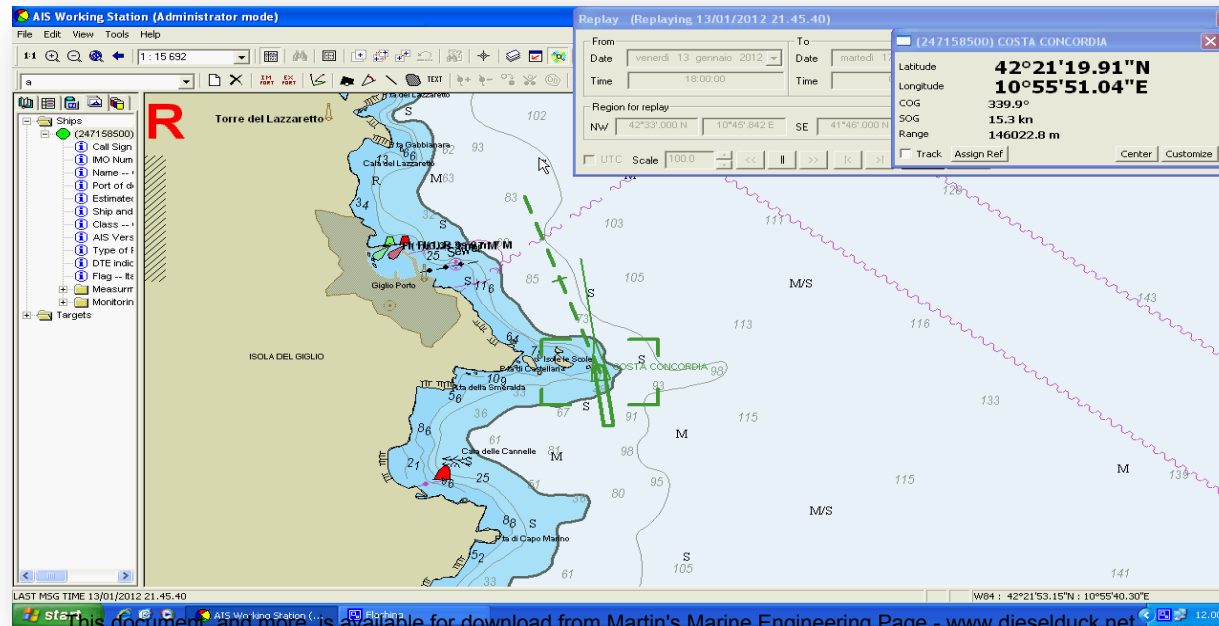
When the Ship is deemed to be sailing too close to the coast the **SEQUENCE OF SHIP MASTER'S ORDERS** is the following:

- 1) "hard to starboard" and the Ship's bow avoids the shallows;
- 2) "hard to port", but the Ship's stern cannot avoid them

**09.45 pm : COLLISION** between the port side of the hull and the eastern rock of "Le Scole"

- 3) "hard to starboard" and the ship speed reduces instantly up to 8,3 knots, drifting off in headway, on a heading of 350°

**IMMEDIATELY the two Ship's main electrical engines lose power**

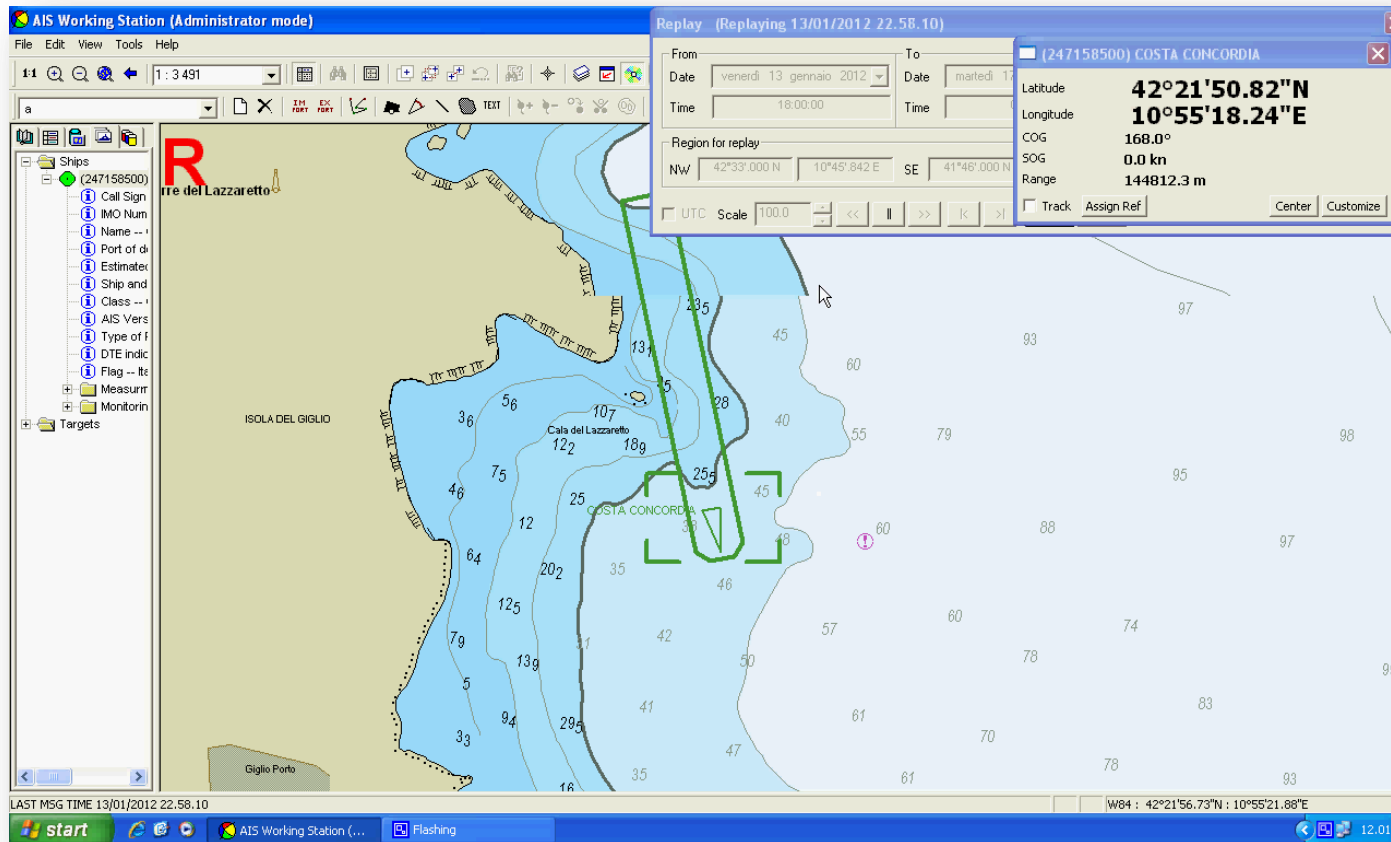
At 10.58 pm

Almost in **final grounded position**, struck, Lat  $42^{\circ}21'50''\text{N}$  – Lon  $010^{\circ}55'18''\text{E}$   
*Island of Giglio – Cala del Lazzereto*

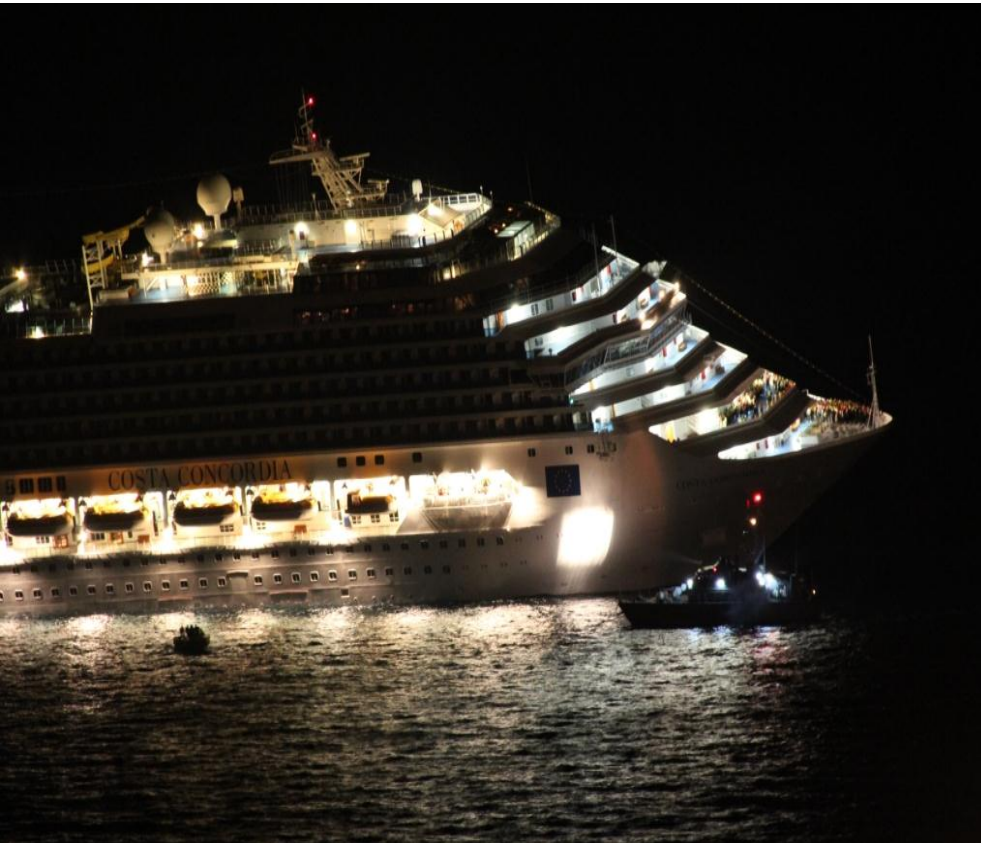
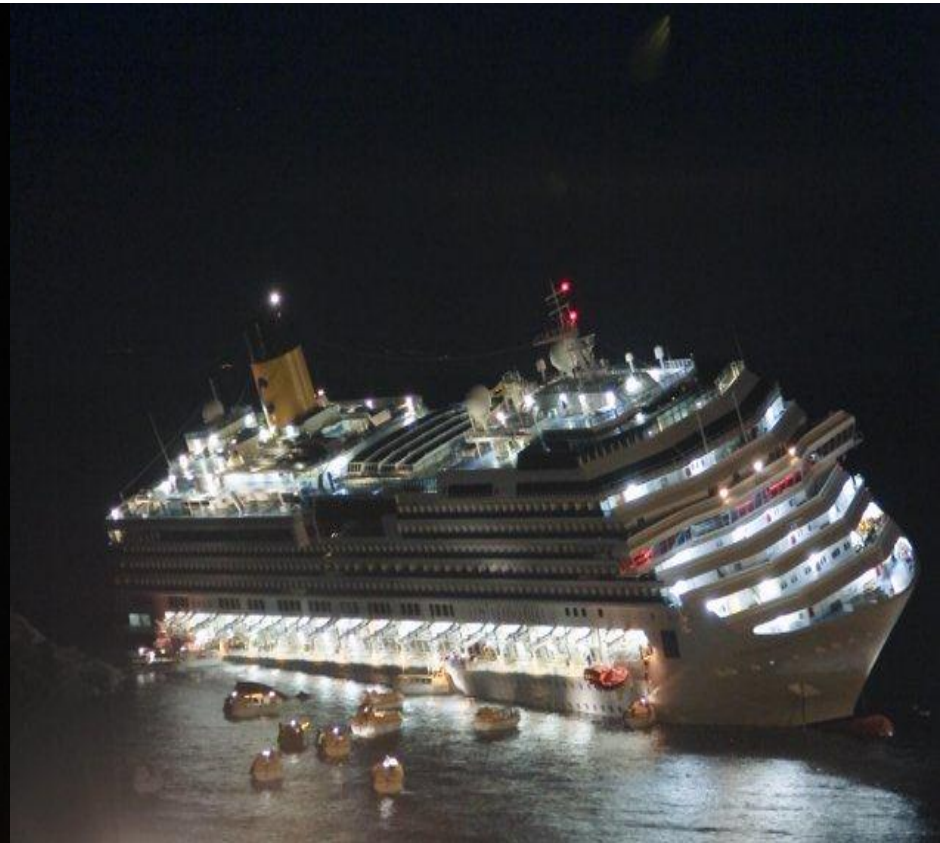
*The pictures were taken from the Island of Giglio  
the image does not correspond to the present history of events, but it is noteworthy for showing the exact  
moment when the lifeboats are launched on the starboard side*

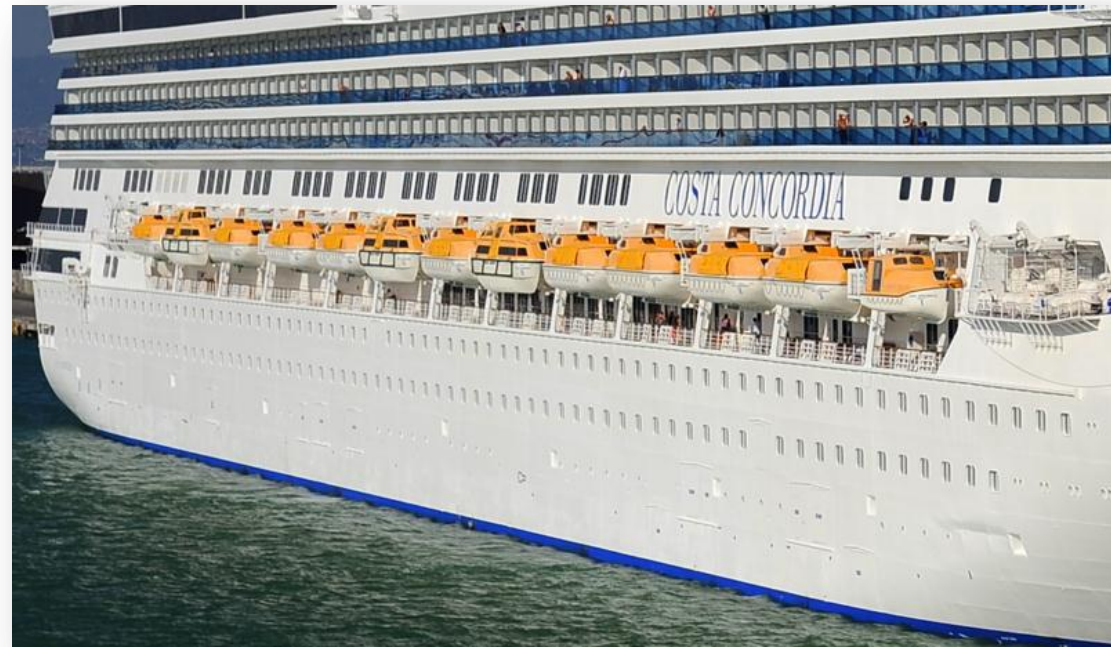
- 26 lifeboats
- 23 the launched ones
- 3 lifeboats on portside could not be launched due to the significant list of the vessel

- 6 Liferrafts were launched

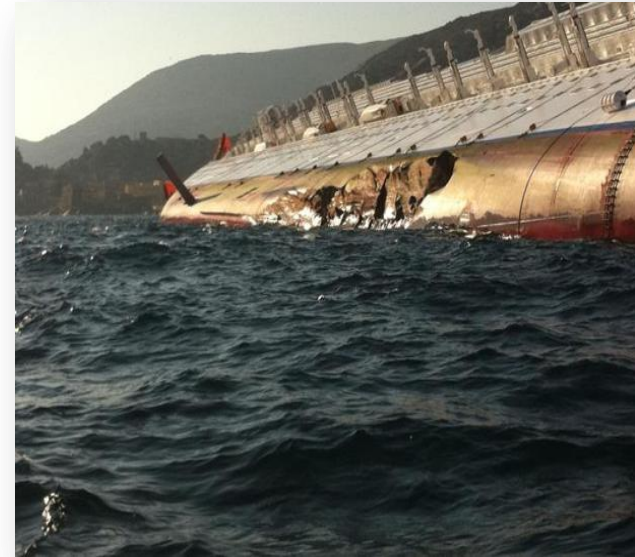
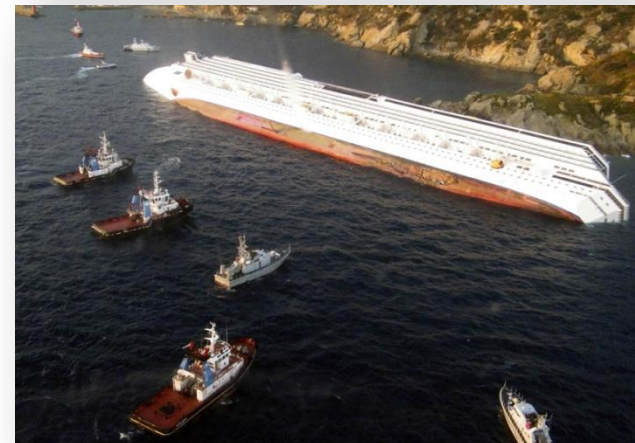
**Damage between frame no. 58 and frame no. 125/128,  
creating a 60 meters hole into the hull – portside**

- **The two most affected watertight compartments (contiguous), immediately flooded:**
  - no. 5 (Propulsion Electric Motor)
  - no. 6 (aft generators)
- **Partially flooded at the time of crew inspection (10 minutes after the impact)**
  - no. 7 (forward generators)
  - no. 4 (Galley compressors)

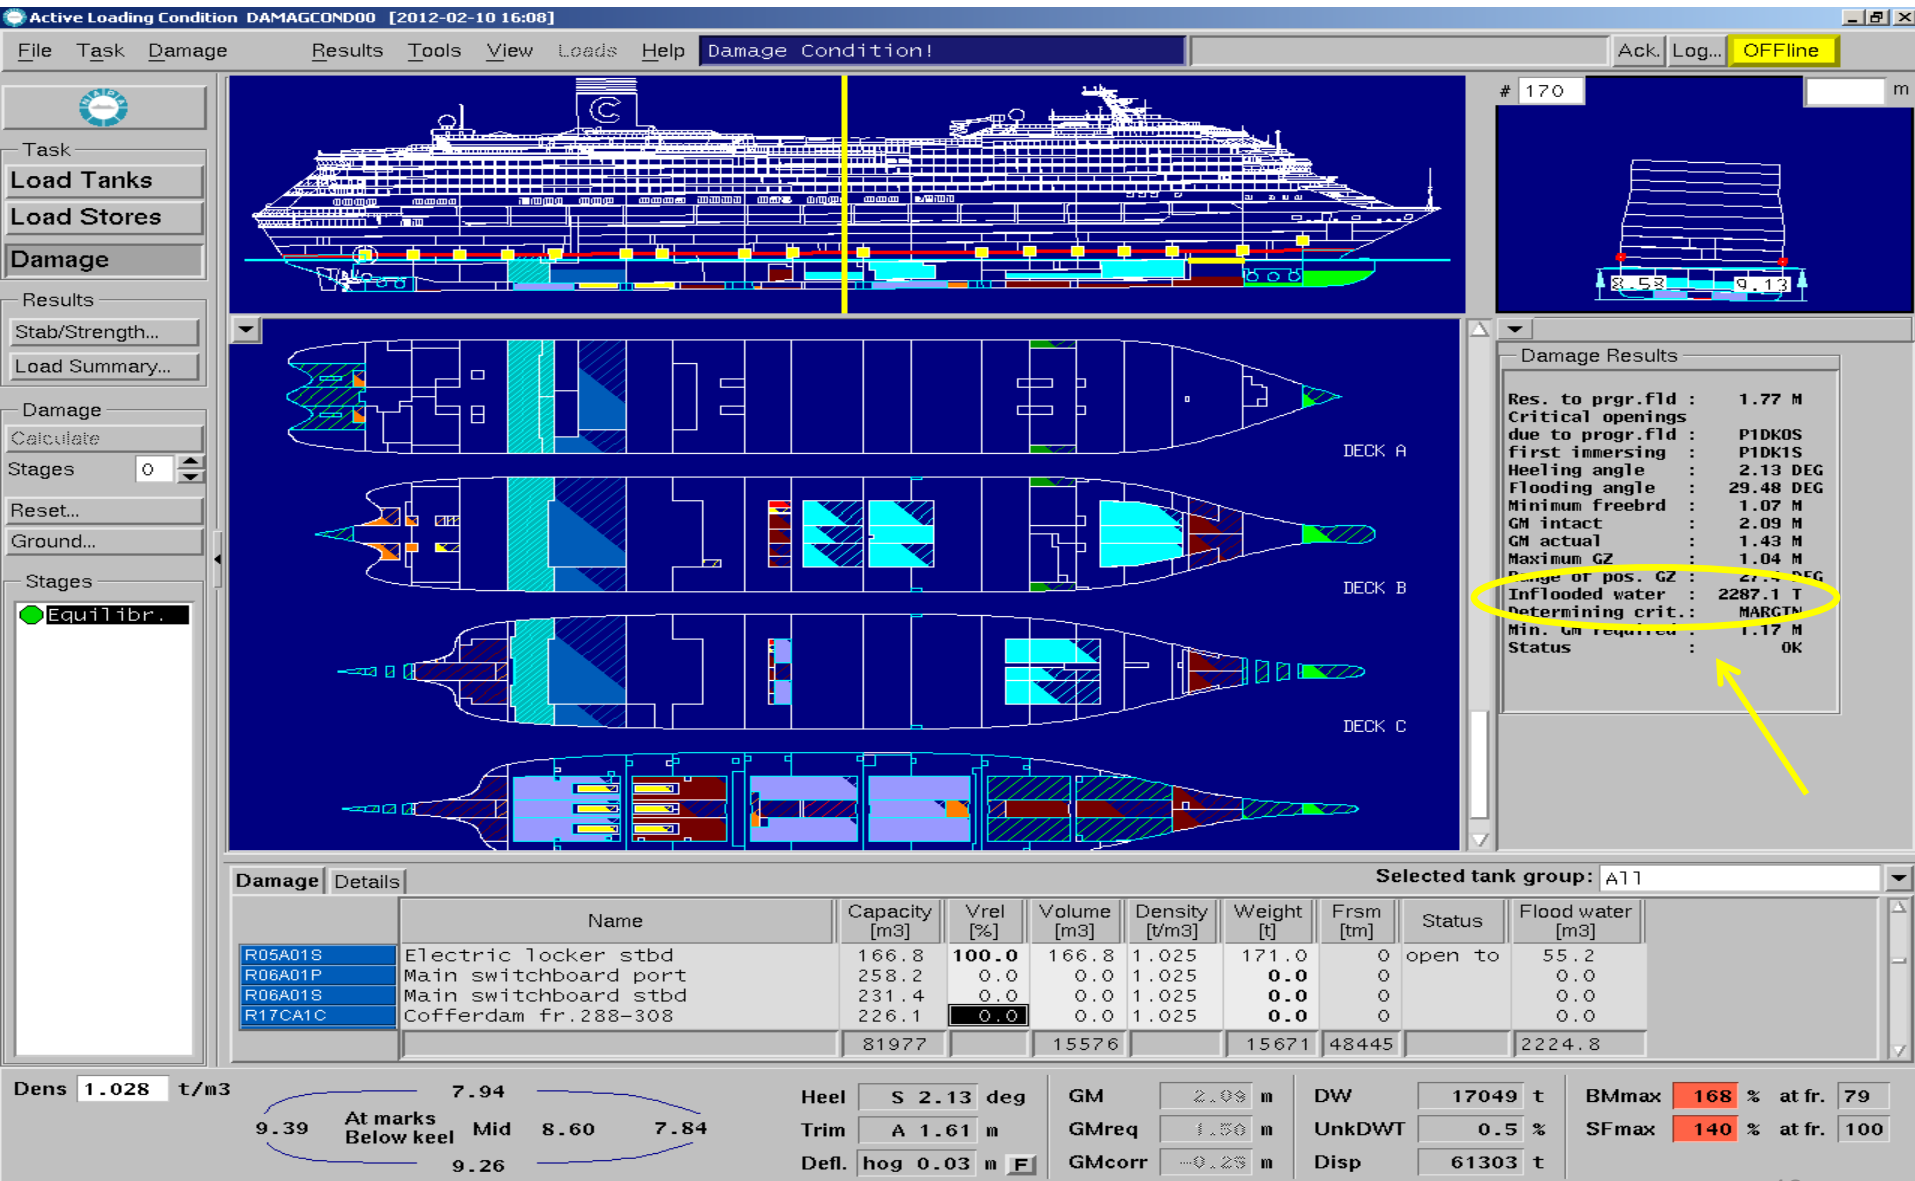
# Costa Serena simulation after the impact – Damage condition 0

## Compartment no. 5 flooded immediately 2287.1 t of water

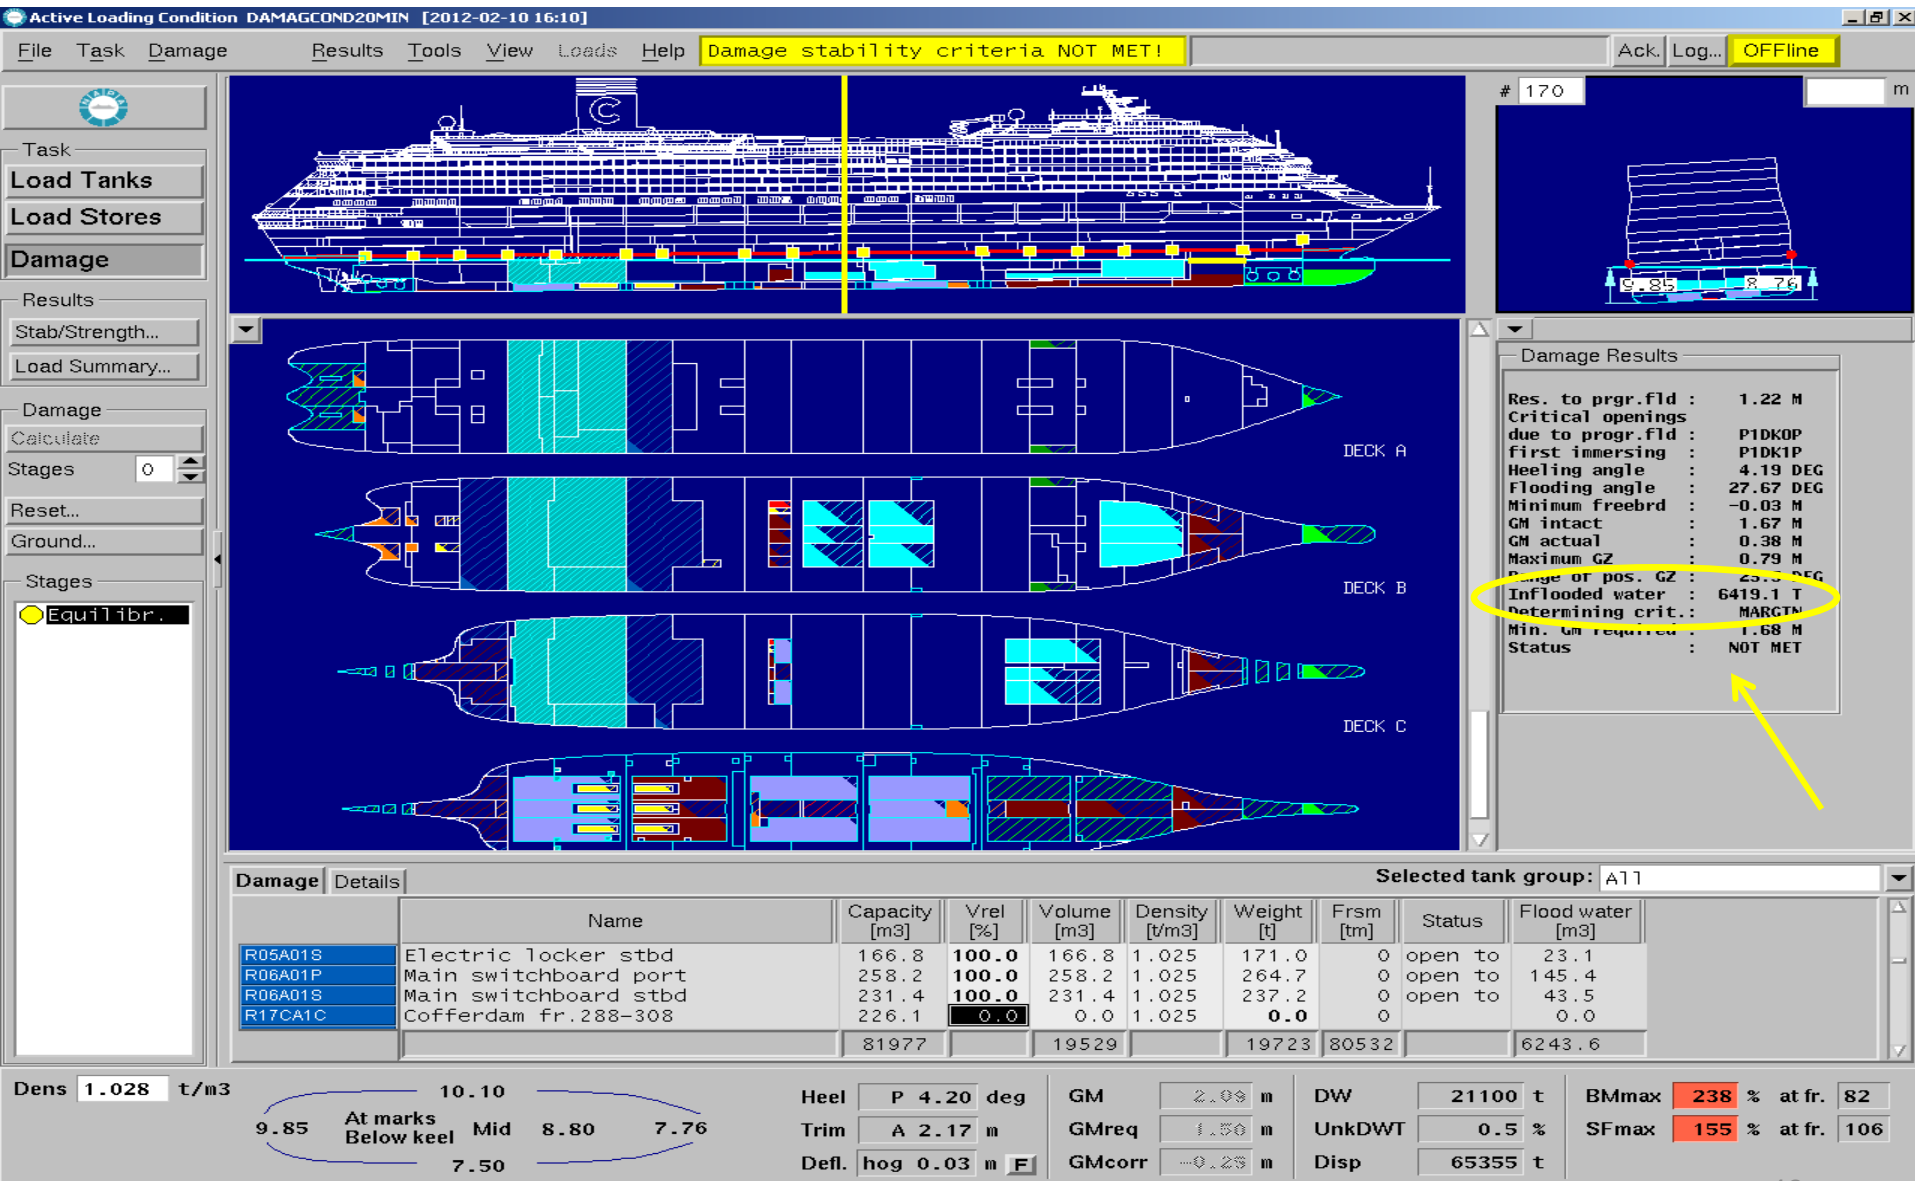
# Damage condition after 20 minutes inflowed water 6419.1 t

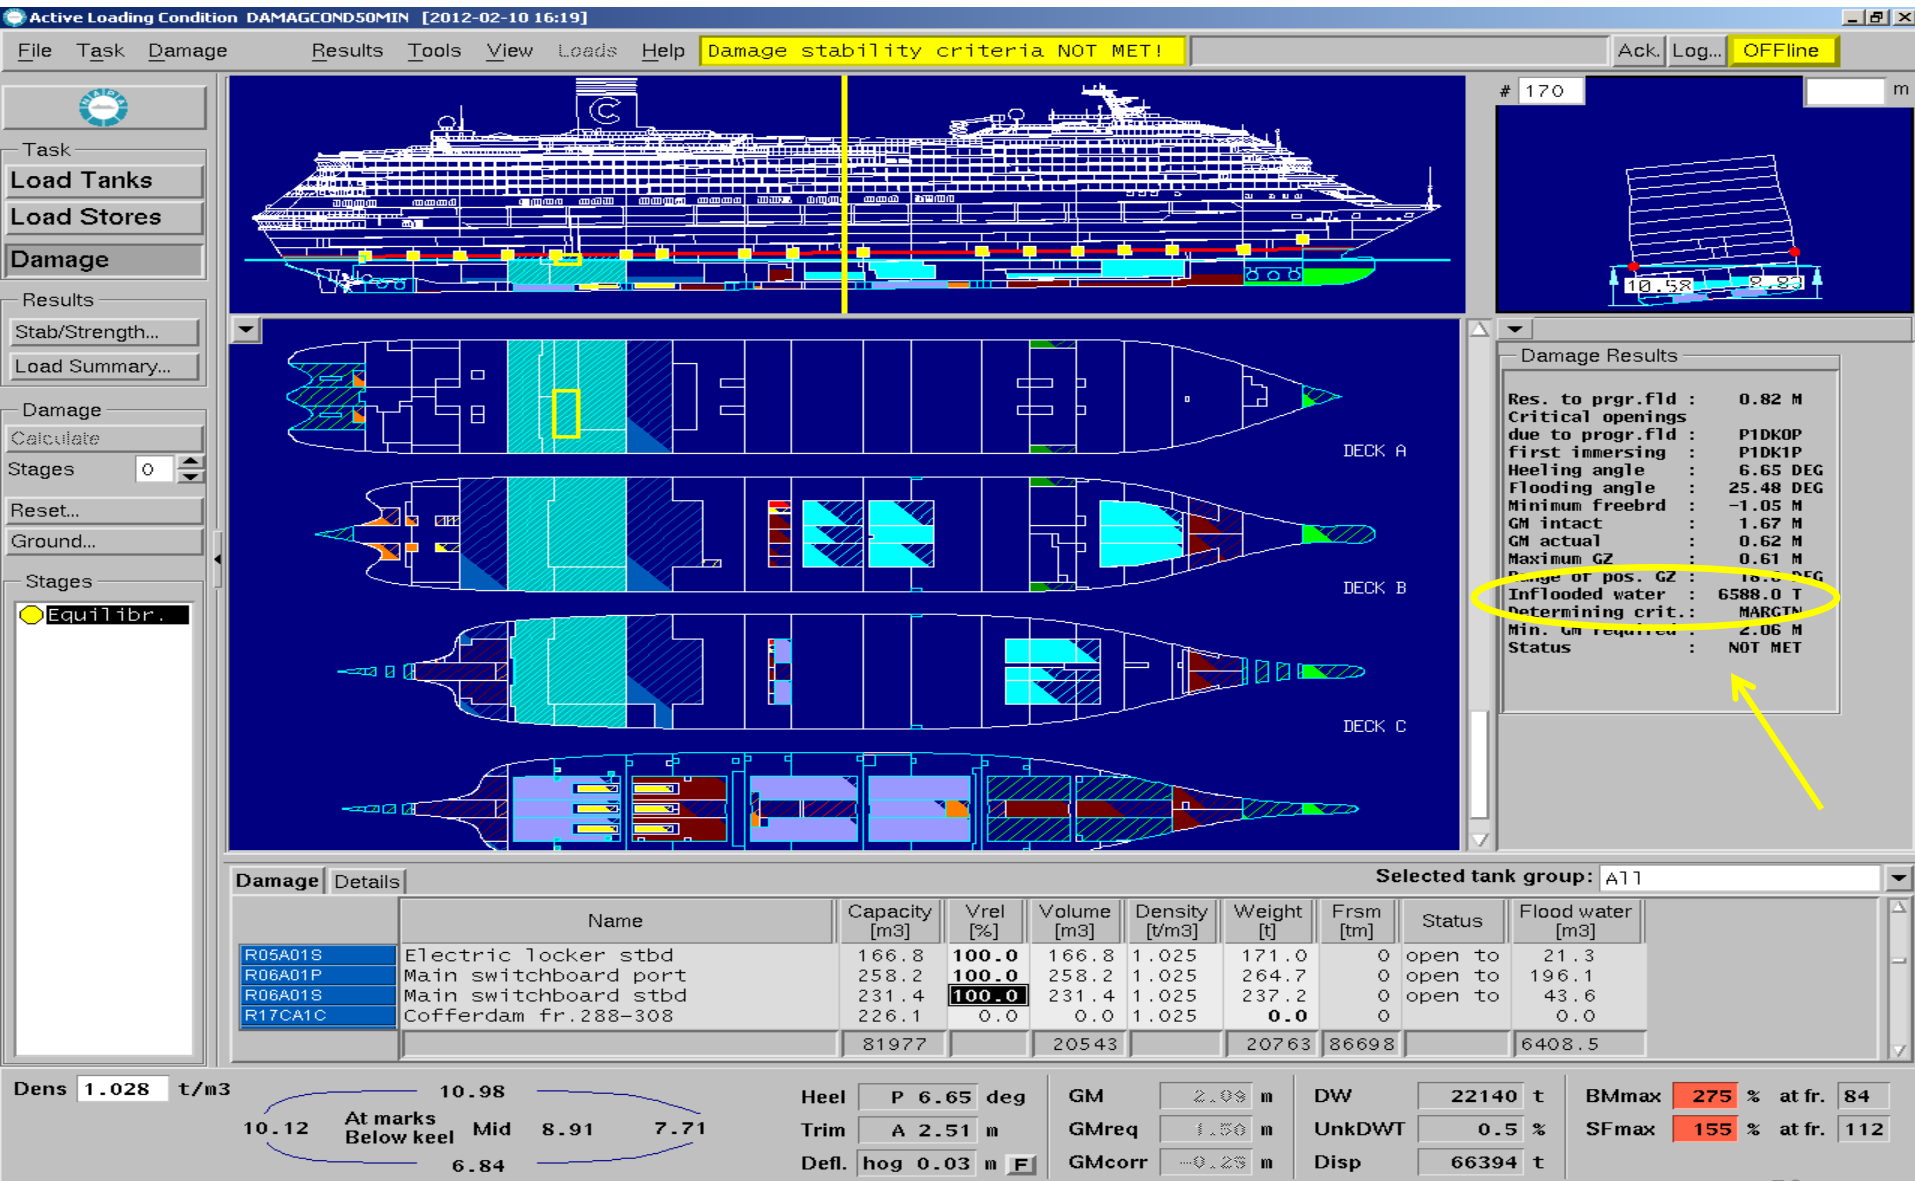
# Damage condition after 50 minutes inlooded water 6588.0 t

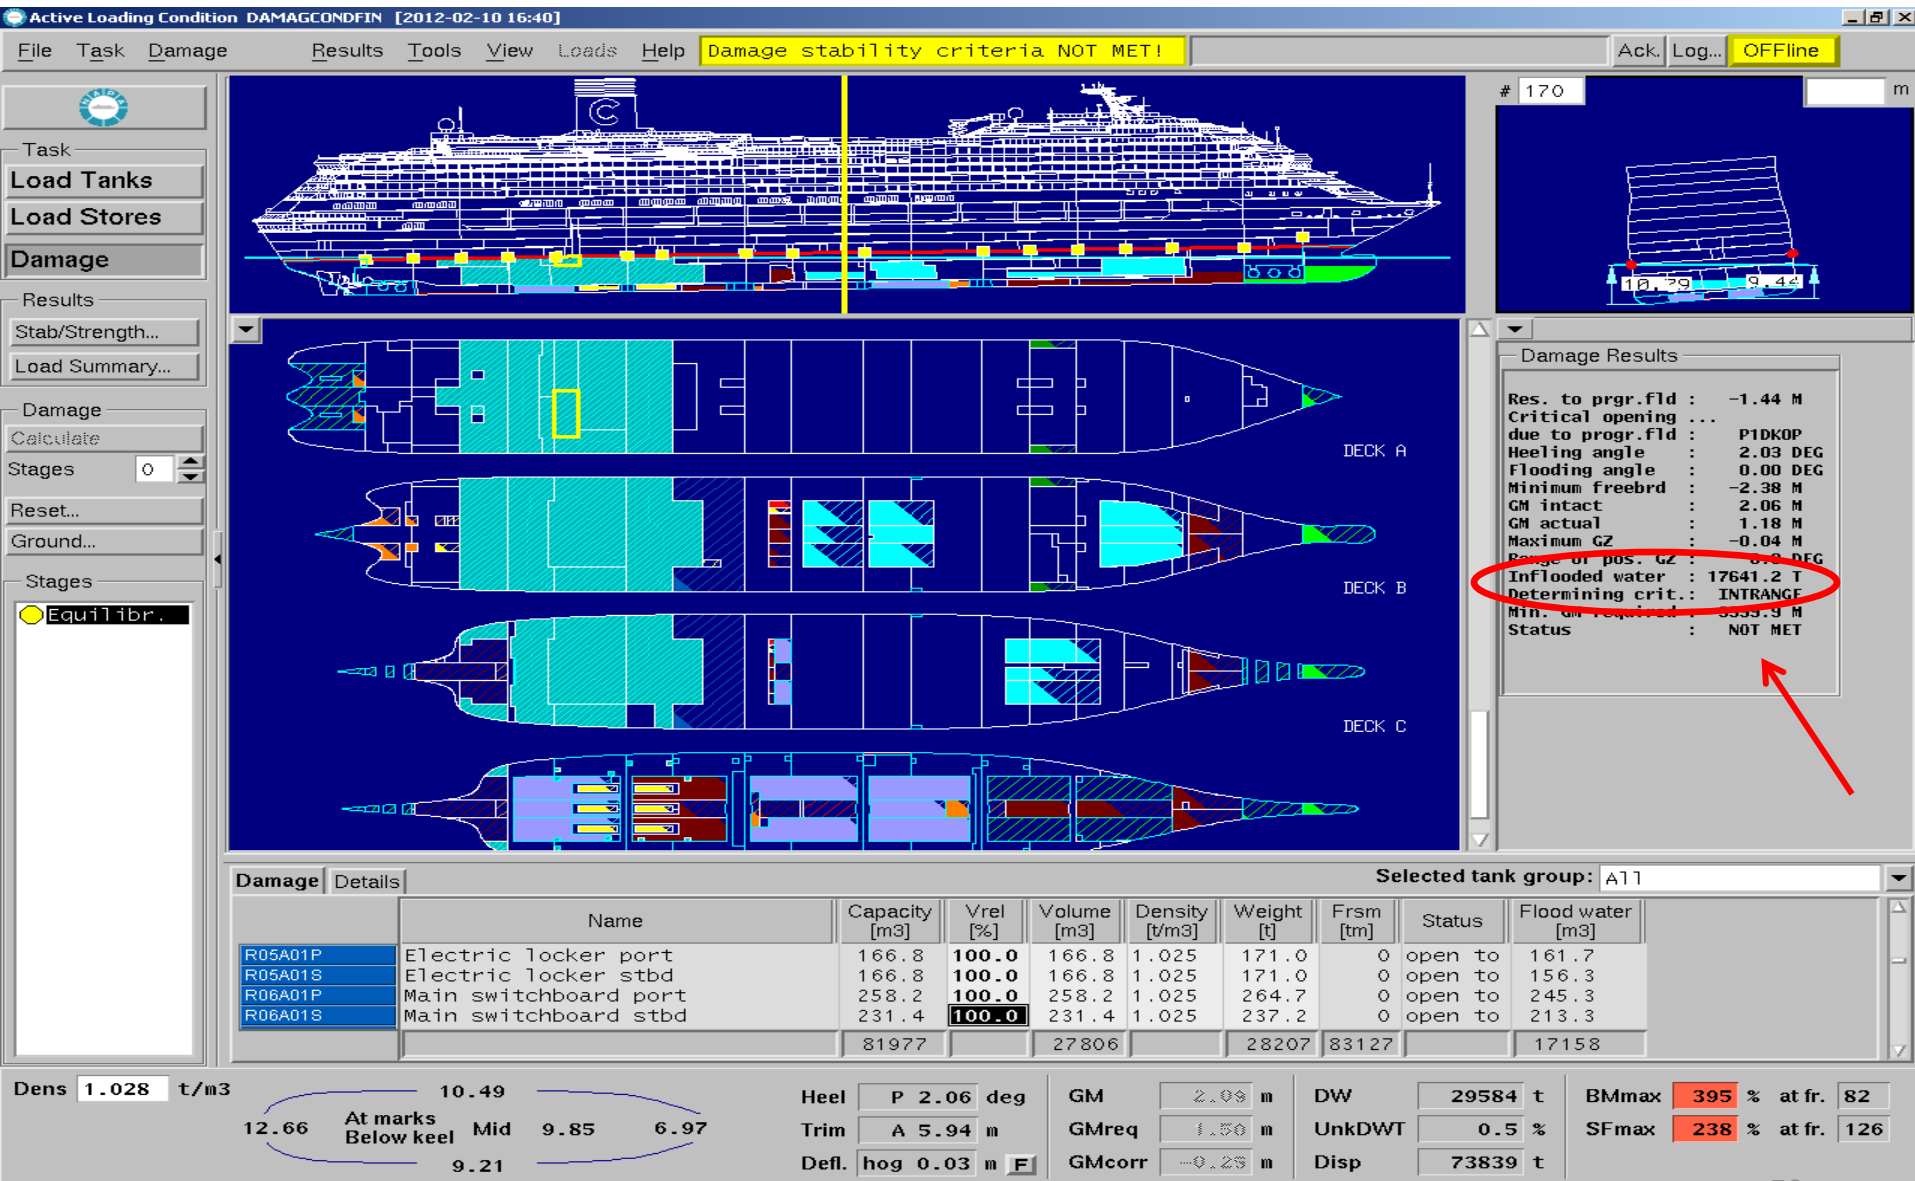
# Damage final condition inflowed water **17641.2 t**
