Cruise liner accident highlights many problems including with emergency power generation

Costa Concordia capsizes

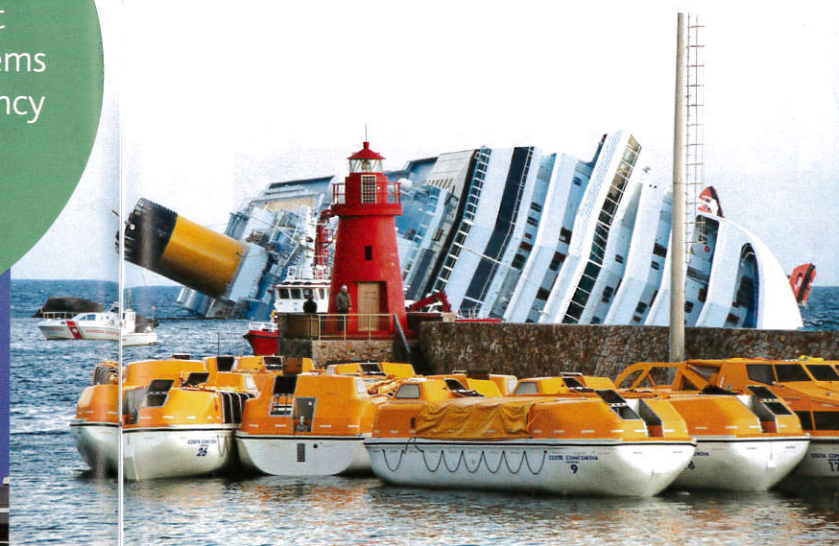
The capsized vessel with some of its lifeboats in the foreground

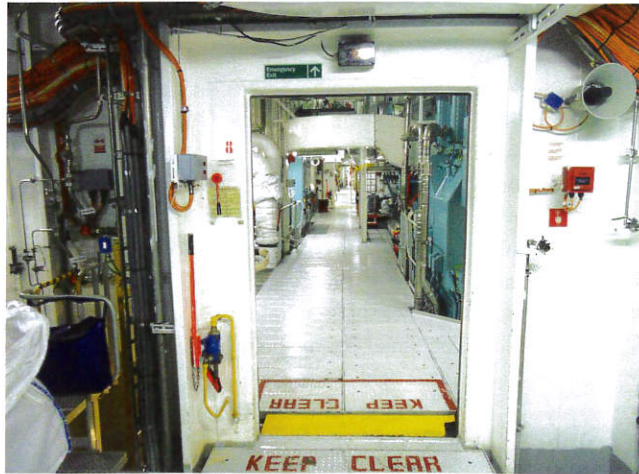
The ship suffered an immediate 'shut down' due to the violent entry of water in uncontrollable quantities that in less than a minute affected the stern DG Room (WTC 6, where three main generators were sited) and the PEM room (WTC 5). The blackout, in fact, is recorded 51sec after hitting the rocks. The consequences of the violent water entry had irreversible effects - the ship lost propulsion immediately, and all services.

Looking through WTCs 6 and 7 from WTC 5 (actually aboard sistership, the *Costa Serena*)

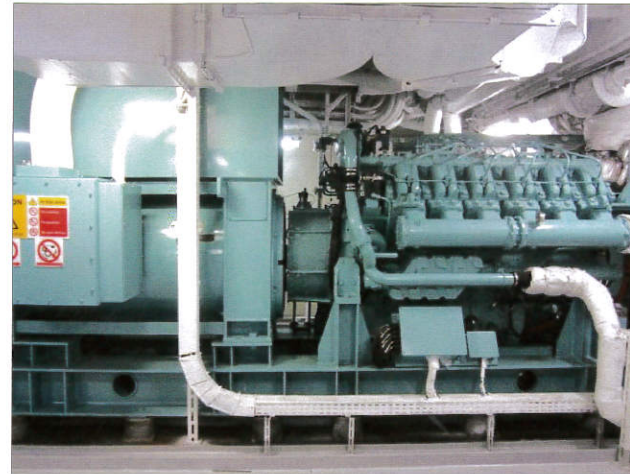
The emergency genset aboard the *Costa Favolosa*

Immediately after the impact a blackout occurred at 21.45.47 - the emergency generator started but supplied power for just 41secs.

According to the declarations of the first electronic officer, the first electrician and the first mate it has been concluded that the emergency diesel generator was not able to perform the designed service notwithstanding the crew's efforts to guarantee its working.

Amongst the many recommendations made by the report is one concerning emergency generators. It is proposed that emergency generator capacity be increased to also feed the high capacity pump(s) which are also proposed in the report. In addition a second emergency diesel generator should be provided, located in a separate main vertical zone from the first emergency generator, and above the most continuous deck. This second generator could be dimensioned on the basis of selected services.

- new emergency diesel generators to be made according to specific building techniques to guarantee reliable and long-lasting operation
- regulate function tests, planning them once a week, under a significant load (at least 50%) and of at least 2h duration for both emergency diesel generators. □

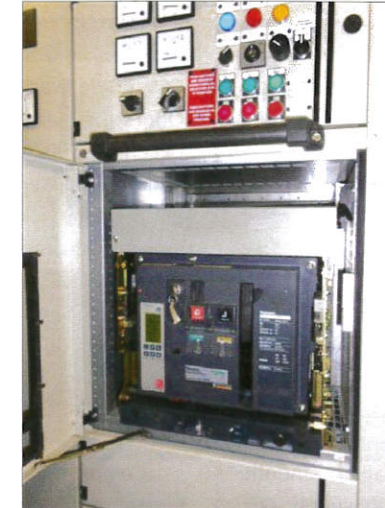
The EEQ was engaged at 22.10.52, after the arrival of the electrician officer in the EDG room. He immediately identified the problem, gave manual winding with the handle to the spring of the switch 901. Then, noting that the system did not, nevertheless, allow the engagement of the EDG to the related electrical network, used a screwdriver, relying on the blade to make mechanical interconnection inside the switch, to connect and engage the EDG to the emergency power grid.

Finally, the electrician officer made a sort of chock with a cloth to avoid standing still with his hand on the screwdriver blocking the connection of switch 901.

Switch 901, also aboard the *Costa Favolosa*
