## Tips for the operator

Extracts from ABB Turbocharging's  
Turbo Magazine 1990 – 2007

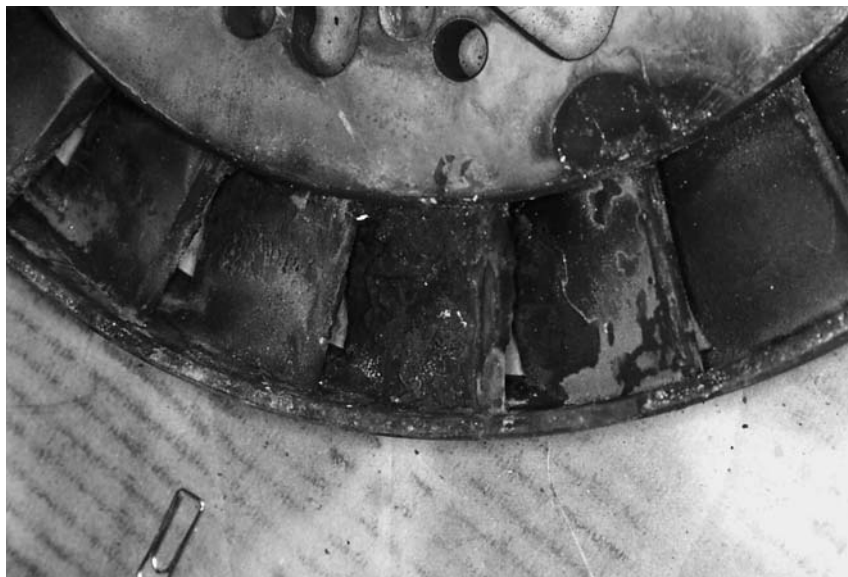
Dirty nozzle ring. Cleaning was not carried out according to our recommendations.

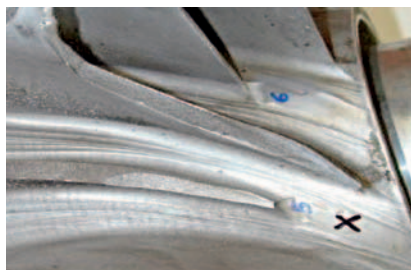
Inducer wheels are not subjected to the kind of loads that some other turbocharger components<sup>1</sup> have to withstand, which is why the rating plate on VTR/VTC turbochargers gives no replacement intervals for them. However, the main and splitter blades of the inducer wheels are susceptible to damage in the form of high cycle fatigue (HCF).

Metallurgical investigations have shown that an initial cause of blade fracture can be pitting corrosion, leading to “notch effect”. Pitting originates when the turbocharger is at standstill and is caused by water-soluble residues such as sulphur (in the exhaust gas) and/or salt (in the intake air).

Damaged inducer wheel.

Critical corrosive attack can be detected by means of non-destructive checks. ABB therefore recommends periodic fluorescent penetrant inspections on the inducer blade surfaces (if this is not possible, the blades can be dye-checked). The results of these inspections might indicate that it is necessary to replace the inducer wheel immediately or during the next overhaul as a precaution against sudden failure.

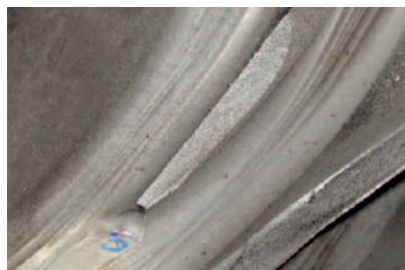
Close-up of a broken splitter blade.

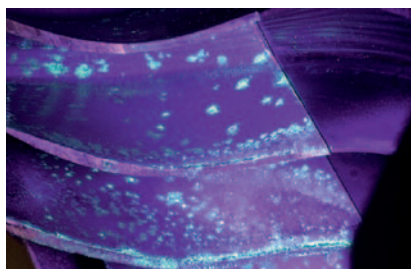
Pitting corrosion revealed on inducer wheel blades by fluorescent penetrant inspection.

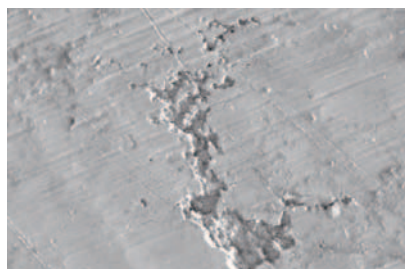
Pitting corrosion (detail).

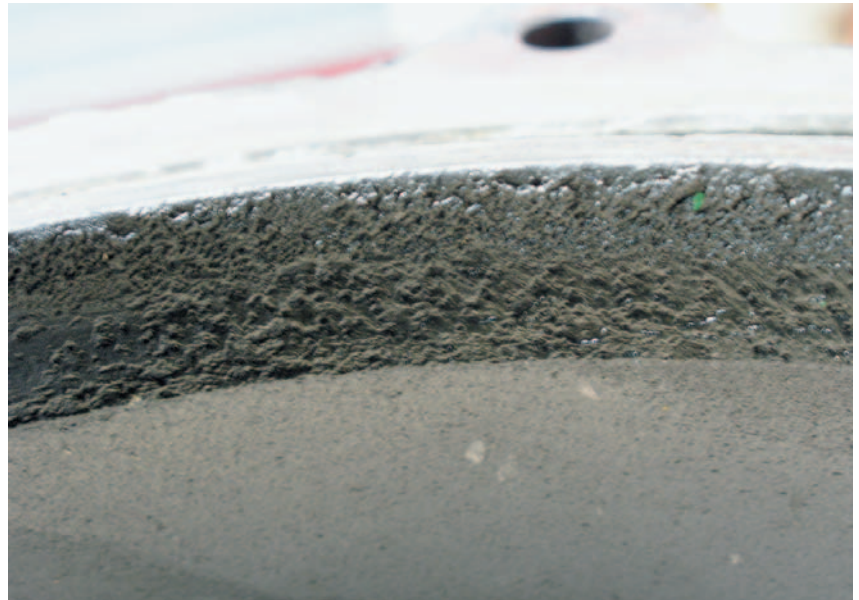
Layer of scale deposited on a turbine diffuser

Chemical analysis of the contamination from some installations burning heavy fuel oil has shown that it is composed of sodium-vanadyl-vanadate compounds. These chemicals promote high-temperature corrosion on metal surfaces exposed to temperatures in the range of 530 °C to 630 °C. The contaminants can also be very hard, so that contact with the turbine blades causes the blade tips to wear.

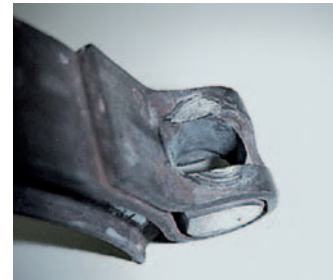
Severe wear at screw-head.

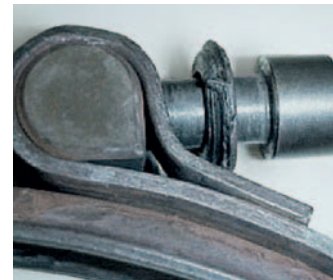
Deformed or wrong washer.

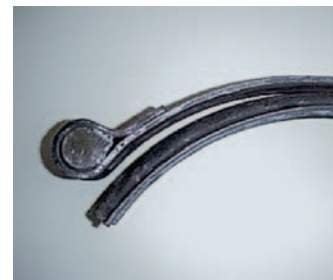
Cover tape detached.

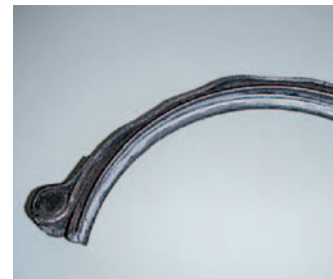
Cover tape severely deformed.

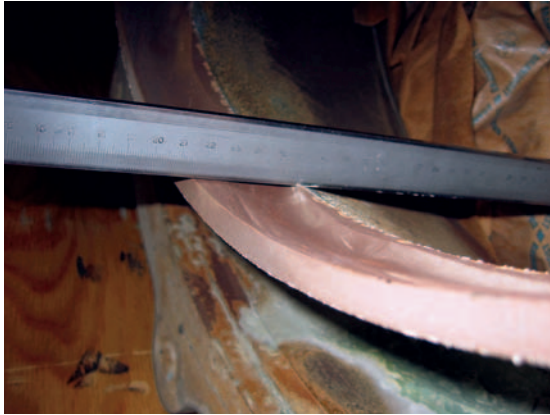
Worn turbine diffuser.

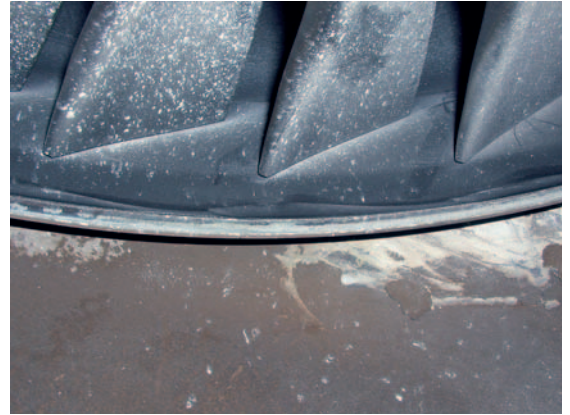
Worn turbine blade tips and turbine diffuser.
