WHAT CAUSED THE STEAM SYSTEM

By **WAYNE KIRSNER, PE,***
Kirsner, Pullin & Associates,
Marietta, Ga.

An investigation into the factors contributing to a rare and little understood class of steam system accident that likely will kill again

ACCIDENT THAT KILLED JACK SMITH?

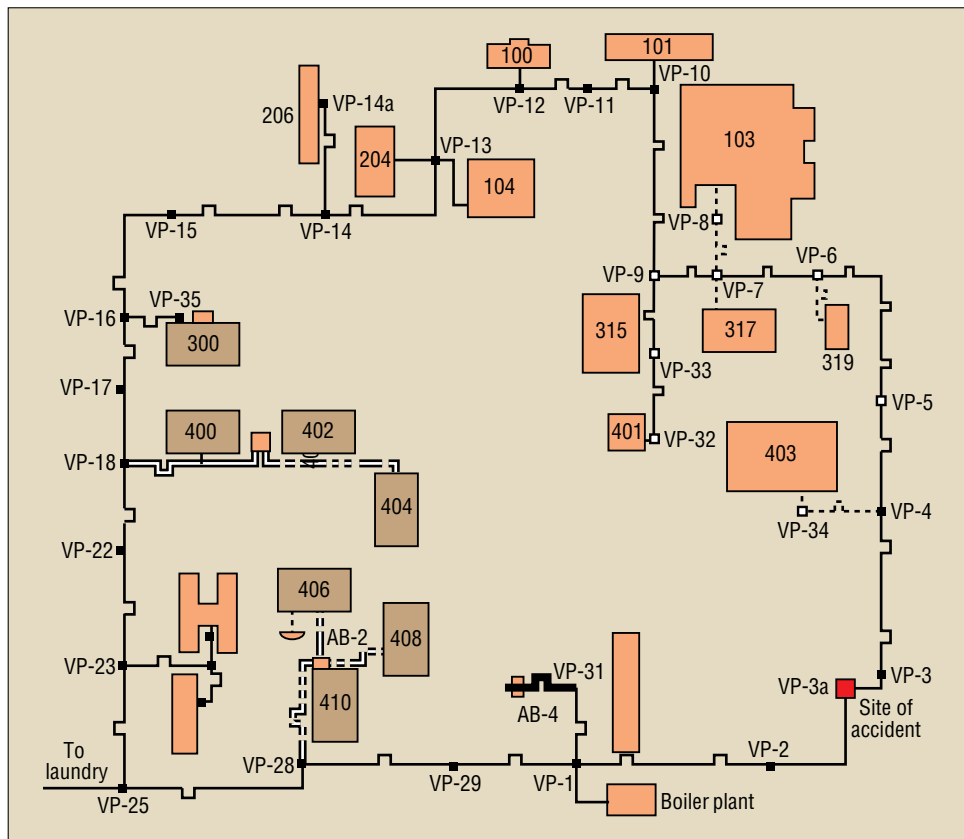
1 Campus steam loop.

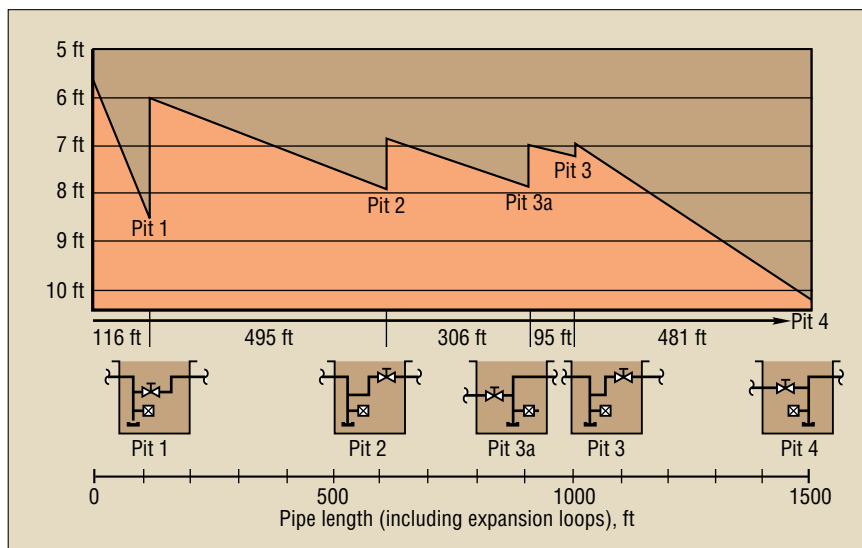
The steam pipe was pitched downward from Pit 1 to Pit 2 (Fig. 2). At Pit 2, the pipe jumped up about 8 in. and then continued its downward pitch to Pit 3. The rivulet of condensate forming at the bottom of the pipe flowed down toward the drip legs provided at the low points

2 Gradient profile of steam main between Pits 1 and 4.

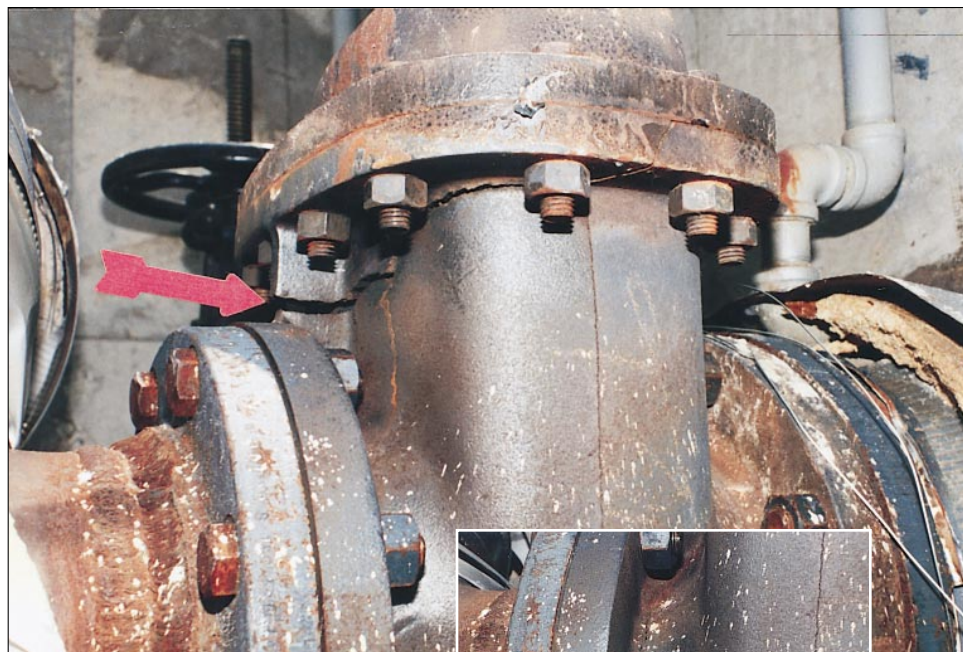
4 Pit 3a 8-in. cast-iron gate valve. Note the broken gusset.

The engineers felt that the physical evidence supported their theory. Fig. 4 shows the valve and pit after the accident. The gusset

connecting the outlet flange of the valve to the steam pipe heading toward Pits 3 and 4 (downstream of Pit 3a from the steam plant) is broken, and a crack extends around the front of the valve up through the valve body bonnet flange. Fig. 5 shows that the crack adjacent to the downstream outlet flange extends around the entire neck of the valve body connected to the flange. In fact, when the valve was removed from its connecting piping, the entire flange fell off, carrying with it a large chunk of the upper valve body at the gusset. The upstream side of the valve (toward Pit 2 and the steam plant) sustained a crack on the back side of the valve body (Fig. 6), but in general, the upstream side of the valve was not as severely damaged as the downstream side.

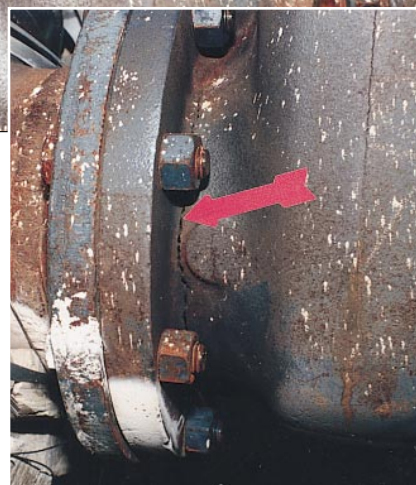
5 Pit 3a 8-in. cast-iron gate valve. Note the crack extending around circumference of flange neck.

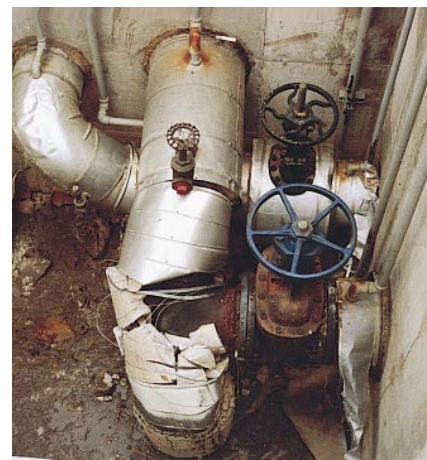
7 Pit 3a after the accident. To the right are Pit 2 and the steam plant; toward the top are Pits 3 and 4.

Take a look at how the drip leg in Pit 3a is supported in Fig. 7. The drip leg actually is the termination of a downturned elbow in the pipe coming from Pit 3. Of course, the original design engineers planned on steam and condensate “going to” Pit 3 from Pit 3a. This is the normal direction of steam flow from the steam plant out into the system. Steam or condensate was not supposed to flow from Pit 3 back to 3a. The elbow and drip leg are supported “officially” from an anchor in the pit wall at the top of Fig. 7, a few feet from the drip leg. “Unofficially,” however, the drip leg and elbow

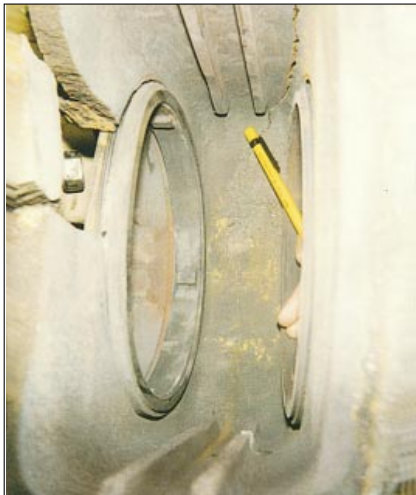
8 Inside of Pit 3a valve. Pencil points to valve disk guides.

densate that broke the valve came from the direction of Pit 3—*i.e.*, from the backside of the steam loop. It would have entered Pit 3a from the top, as shown in Fig. 8, rounded the full radius elbow, and then crashed into the dead end at the bottom of the drip leg, wrenching the drip leg and its elbow violently down.

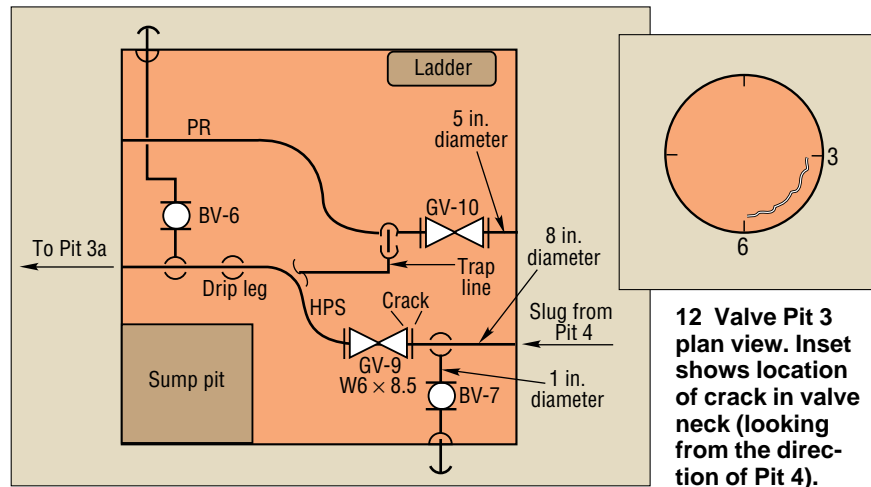
12 Valve Pit 3 plan view. Inset shows location of crack in valve neck (looking from the direction of Pit 4).

Additional damage found at Pit 3 after the initial accident supports the theory that the slug came from this direction. At Pit 3, a crack was found in the flange neck of the cast-iron gate valve, and the valve’s connecting gasket was blown out. But if the slug that

Examine the schematic diagram of the Pit 3 layout in Fig. 12, taken from the design engineer’s drawings. The layout is very different from that of Pit 3a. There is no dead-ended drip leg, as is the case at Pit 3a. The most abrupt change of direction in the high-pressure steam (HPS) main is two long radius 45-deg elbows. The inertial force imposed on the valve when the condensate slug hit this change in direction would be much less than that exerted at Pit 3a. Nonetheless, the reaction force was apparently enough to crack the valve but not rupture it. The location of the crack, as shown in the figure, is consistent with the location of maximum tensile bending stress placed on the valve body by a slug traveling from the direction of Pit 4 through Pit 3 and heading to Pit 3a.
