# *Engine Accident Cases*

Mitsui O.S.K. Lines  
Marine Engineering Group  
Marine Division

Published June 2001

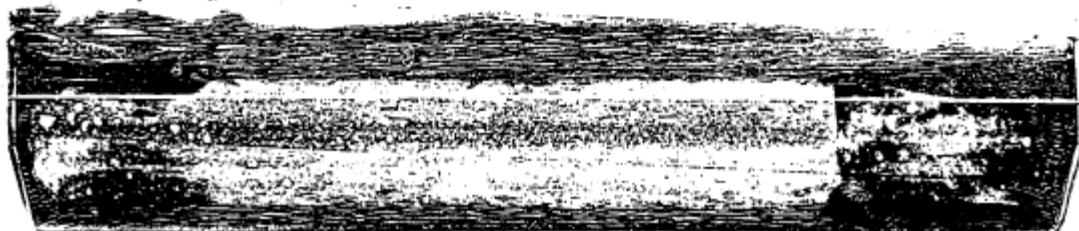
Note mark on tooth => \*\*\*\*\*  
UNIT 4 TOOTH -> AFT MARKING OF 4 DOTS IS CORRECT

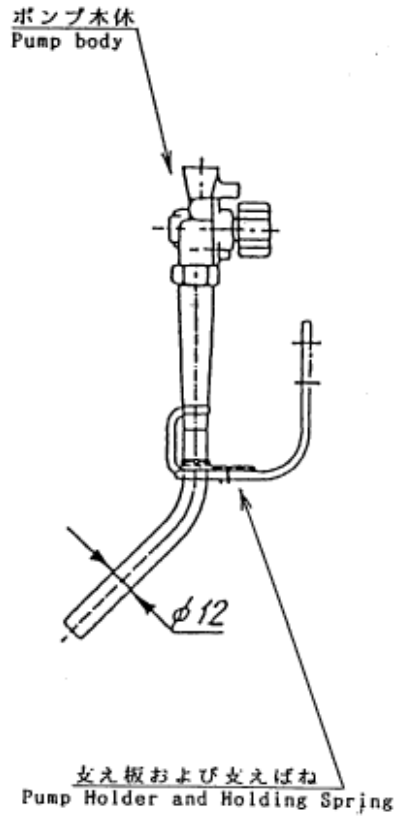
従 来 形  
Former Model

VTR 564/ 564A/ 564E 形過給機用 注油ポンプの変更  
Model Change of Gear Oil Pump of VTR 564/ 564A/ 564E

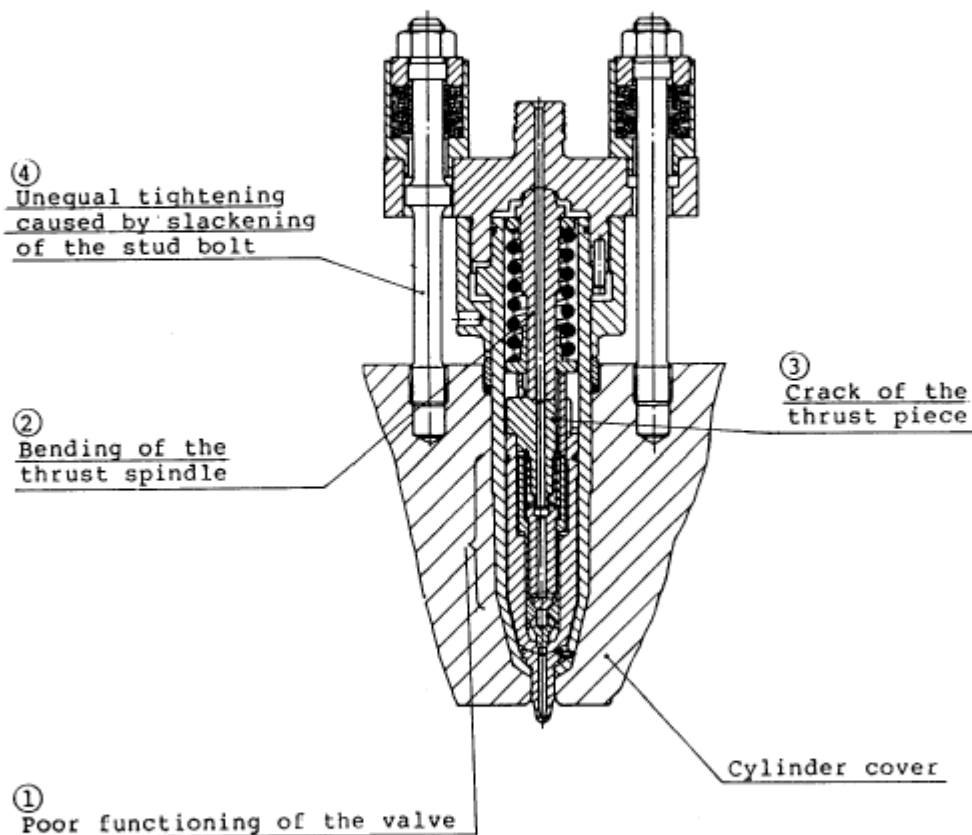
Fig.1 Sectional drawing of the fuel valve assembly

- ① Poor functioning of the fuel valve due to deformation of each part in the fuel valve by excessive tightening.
- ② Bending damage of the thrust spindle by excessive tightening.
- ③ Crack damage of the thrust piece by excessive tightening.
- ④ Poor fuel injection due to unequal tightening caused by the slackening of the fitting stud bolts.

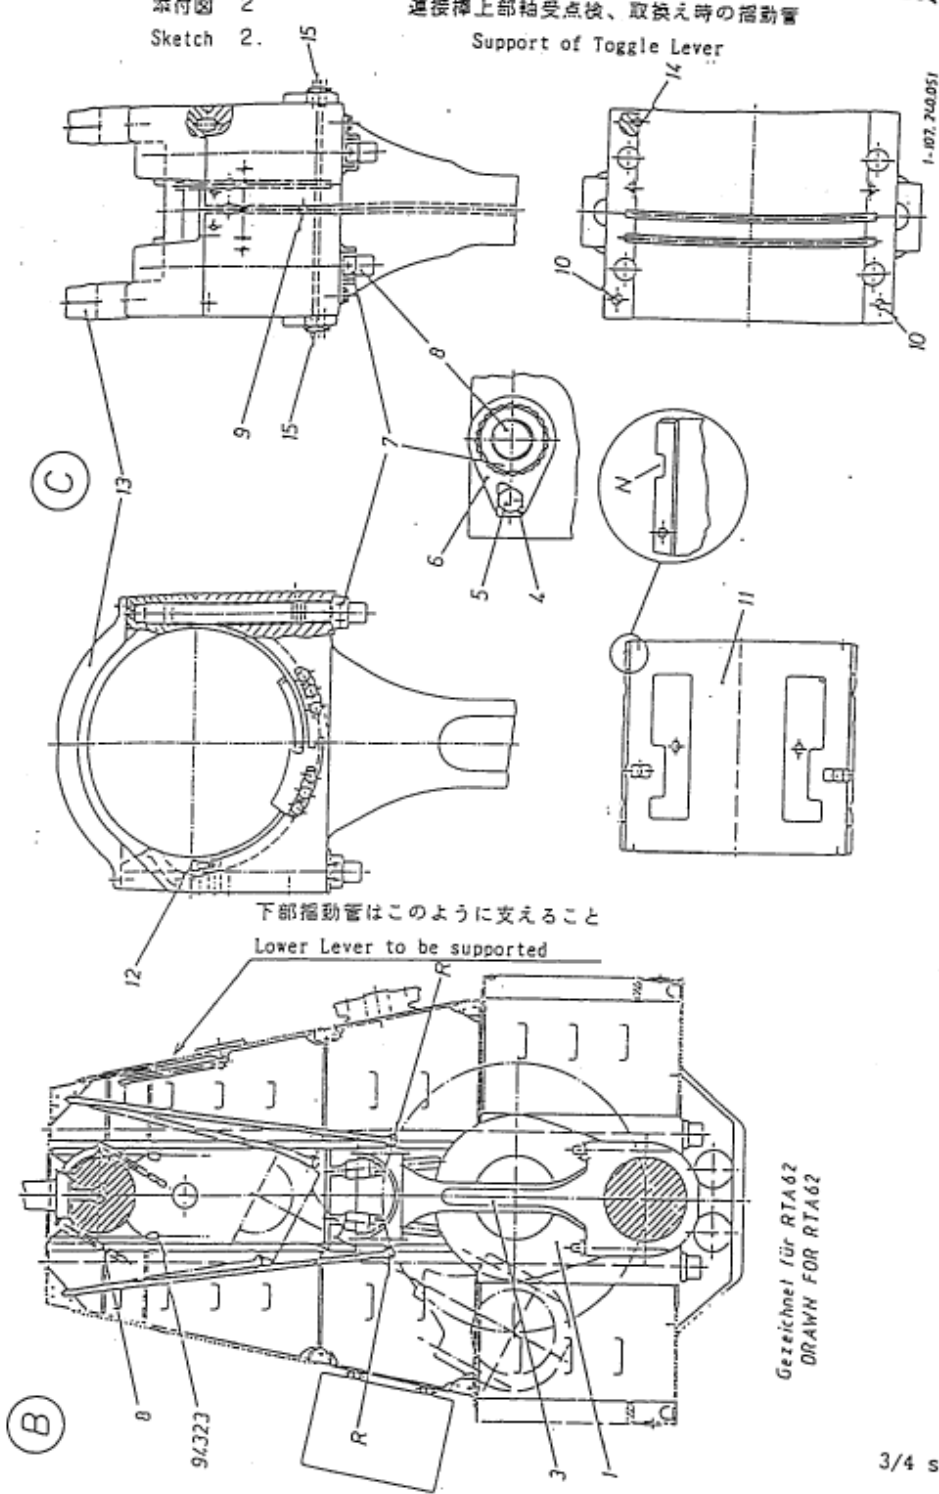
添付図 2  
Sketch 2.

道徳棒上部軸受点後、取換え時の揺動管  
Support of Toggle Lever

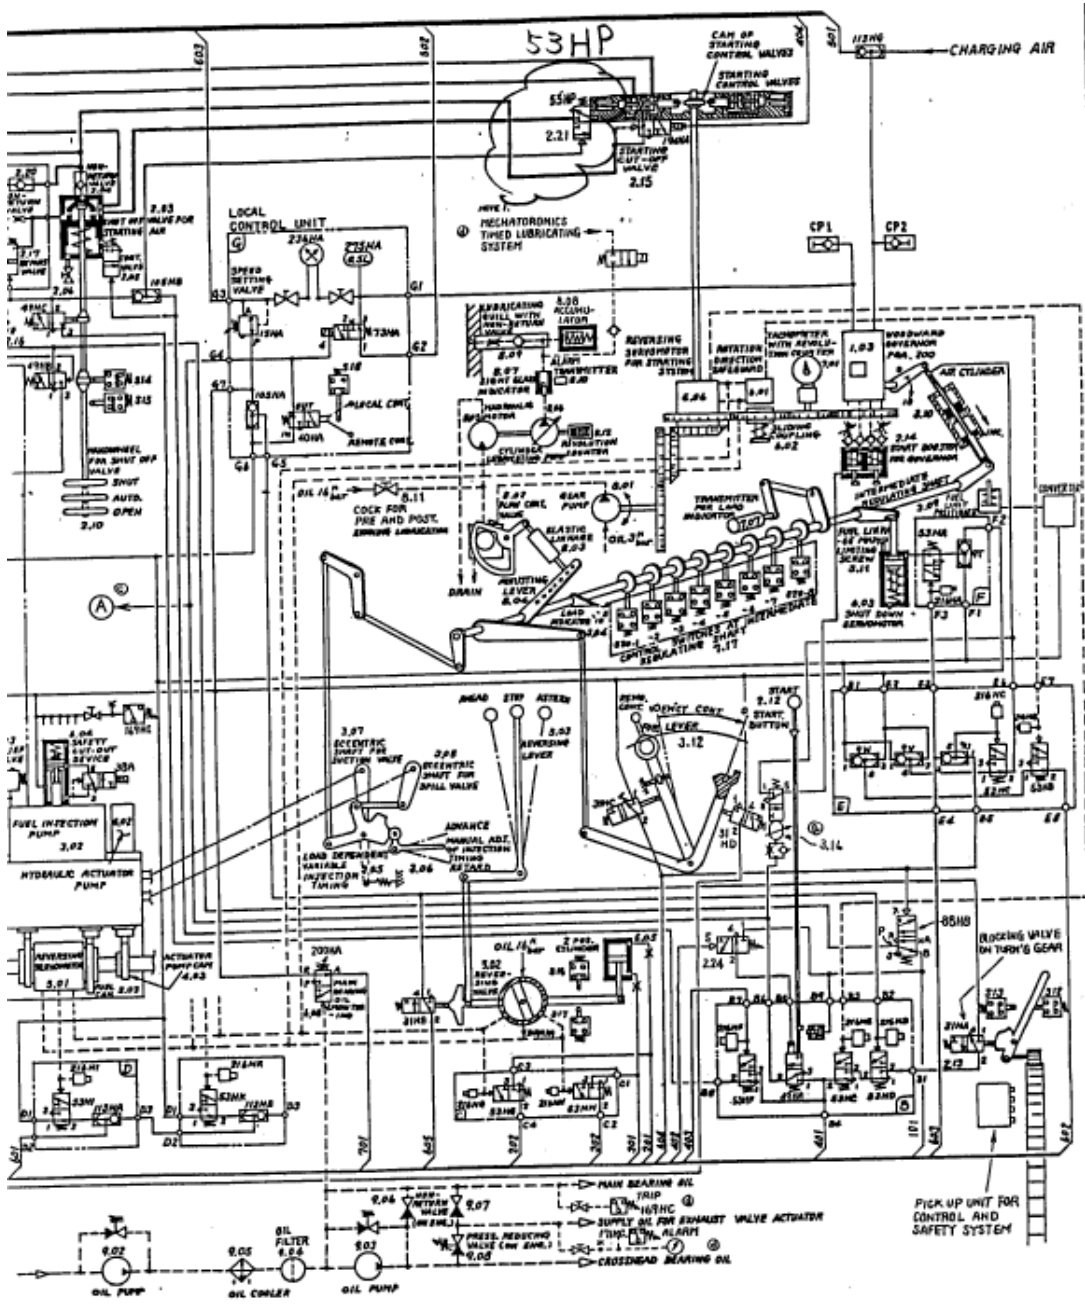
A detailed inspection of the control air line made with reference to the main engine control system diagrams, revealed, in the drawing No. 53HP (three-way valve), a reverse pipe connection of the control air line (7 kg/cm<sup>2</sup>) and starting air line. As a result of the reverse connection, the starting air pressure introduced to each cylinder becomes equal to the control air pressure, causing failures in getting the engine started.

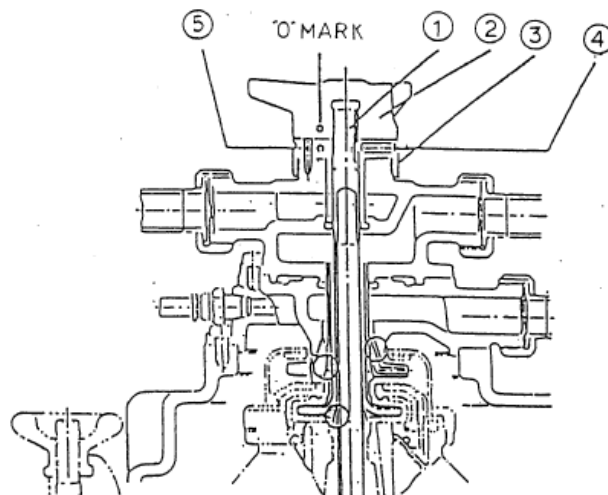
The upper part of SJ-E Series is as shown in the following drawing.  
The Heavy Liquid Impeller and Light Liquid Impeller are incorporated into  
Inlet Pipe and each tapered part (marked ○) is fixed at the prescribed  
position by fastening the Clamp Nut.

1. The following troubles may occur when purifier is operated under the condition of insufficient fastening of Clamp Nut:
  - a) Each Impellers contacts the Heavy Liquid Chamber or Light Liquid Chamber.
  - b) Each Impellers turns by the liquid dynamic pressure and each tapered part abrades.
  - c) In some case, the Inlet Pipe descends and contacts the Distributor.

As the failures mentioned in the above will cause excessive vibration, expansion of parts damages and the generation of heated part, certainly perform the fastening of Clamp Nut in accordance with the undermentioned procedures:

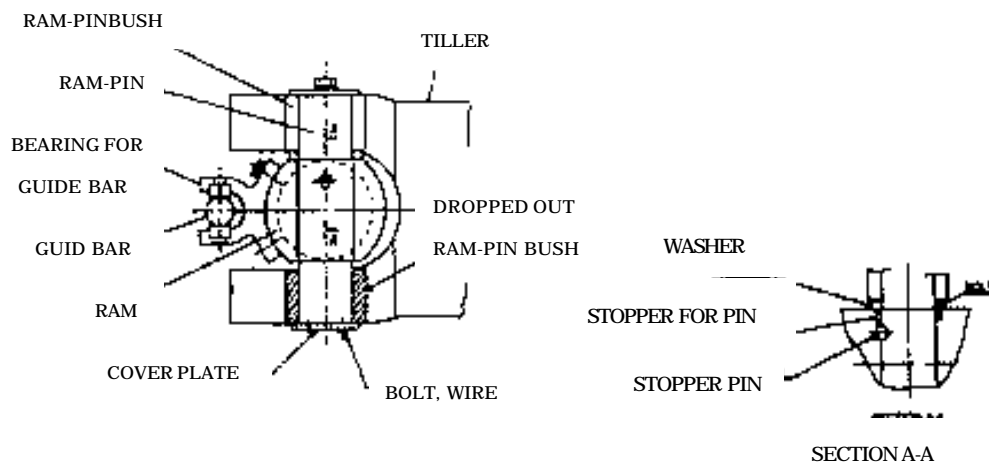
The bolt for the lower cover plate was loose because of poor tightening and vibration. This resulted in the anti-loosening wire becoming torn leading to loosening of the bolts, which eventually dropped out. Finally, the ram-pin bush dropped out (see figure below).

In this incident, DFT-type steering gear was installed on the container vessel. The bolts that connected the washer to the ram were loose, resulting in an upward force being applied to the RAM-PIN. This led to the bolts for the lower cover plate breaking, the RAM-PIN BUSH falling out, and the RAM-PIN being drawn out upwards. Finally, the vessel lost its steering ability.

- The bolt (material: SCM435) should be tightened by a torque of 16 – 17 kgf-m.
- Wire 2.0 mm in diameter should be used.
- The condition of the bolts, wire, ram-pin, and bush should be checked daily.

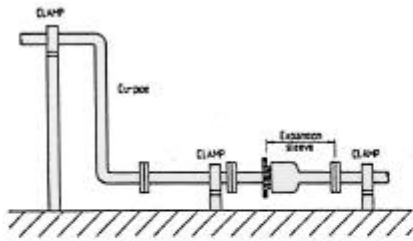
Steam Pipe Line on Deck

Nearly no sleeve type expansion joints are of a rupture-free structure and, for this reason, it is currently necessary to secure them properly to keep them in position.

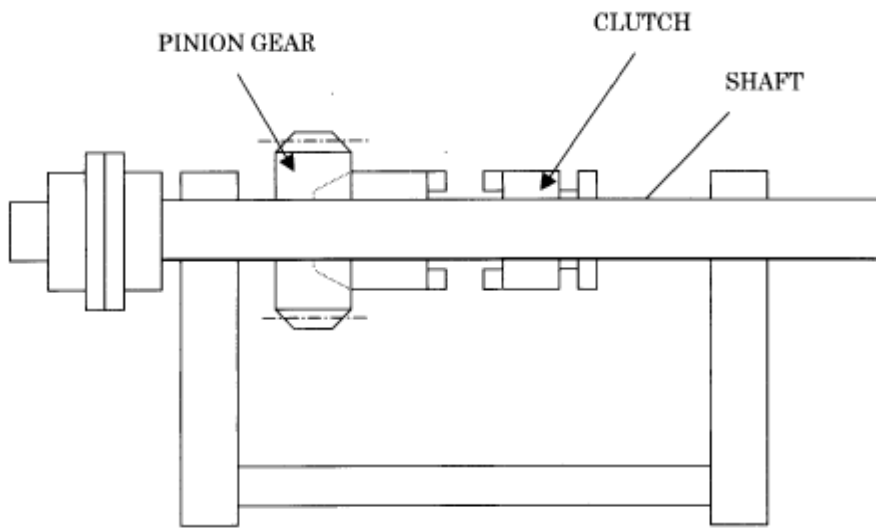
WINDLASS PINION GEAR, SHAFT, CLUTCH

During a mooring operation, the bush for the starboard windlass pinion gear was found having bulged at the end of the coupling, with many cracks on the surface.

This incident is a typical case of damage to equipment which arose from insufficient provision of grease.

New bushes for the pinion gears were manufactured and loaded on board the vessel. Two service engineers from the shipyard stayed on board during a leg from Japan to Singapore to replace the bushes of the windlasses on both sides.

- (1) Each surface of the pinion gear where it came in contact with the bush was rough because of corrosion near the coupling end. It was corrected with hand tools since the work prohibited the use of a lathe. The shaft was also rectified in the same manner.
- (2) The (oversized) bush for the pinion gear was worked on by use of the lathe of the vessel, with an allowance for shrinkage fit of 5/100 to 10/100 mm.
- (3) Each bush which had been kept cold in a refrigerator was struck into each pinion gear which was heated.
- (4) The bushes were provided with set bolts to prevent them from rotating.
