# ITALIAN MARITIME INVESTIGATIVE BODY ON MARINE ACCIDENTS

MARINE ACCIDENT  
INVESTIGATION  
C/S COSTA CONCORDIA  
13<sup>th</sup> January 2012

*MSC90*  
*London - May 18<sup>th</sup>, 2012*

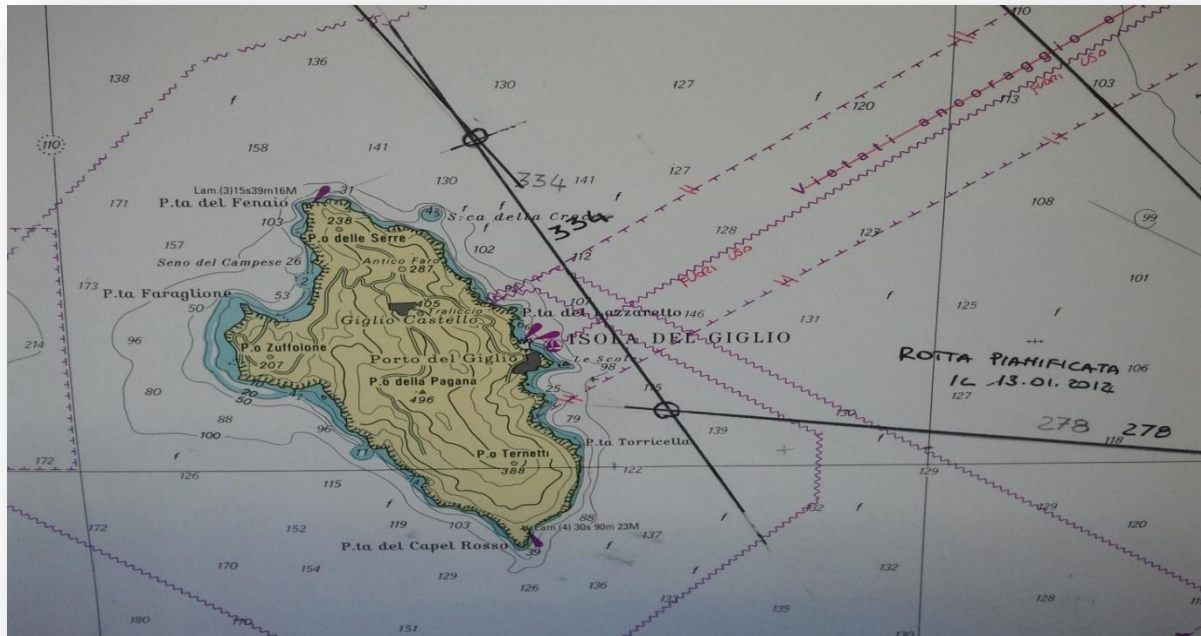
Passage 0,5 miles from the bathymetric limit of 10 meters depth, abeam “Le Scole Reef” (Island of Giglio).

The Ship's **Integrated Navigation System** (Nautical Chart nr. 6 - scale 1:100.000 of Italian Hydrographic Service and the Electronic Cartography – ECDIS ) reports the planned course.

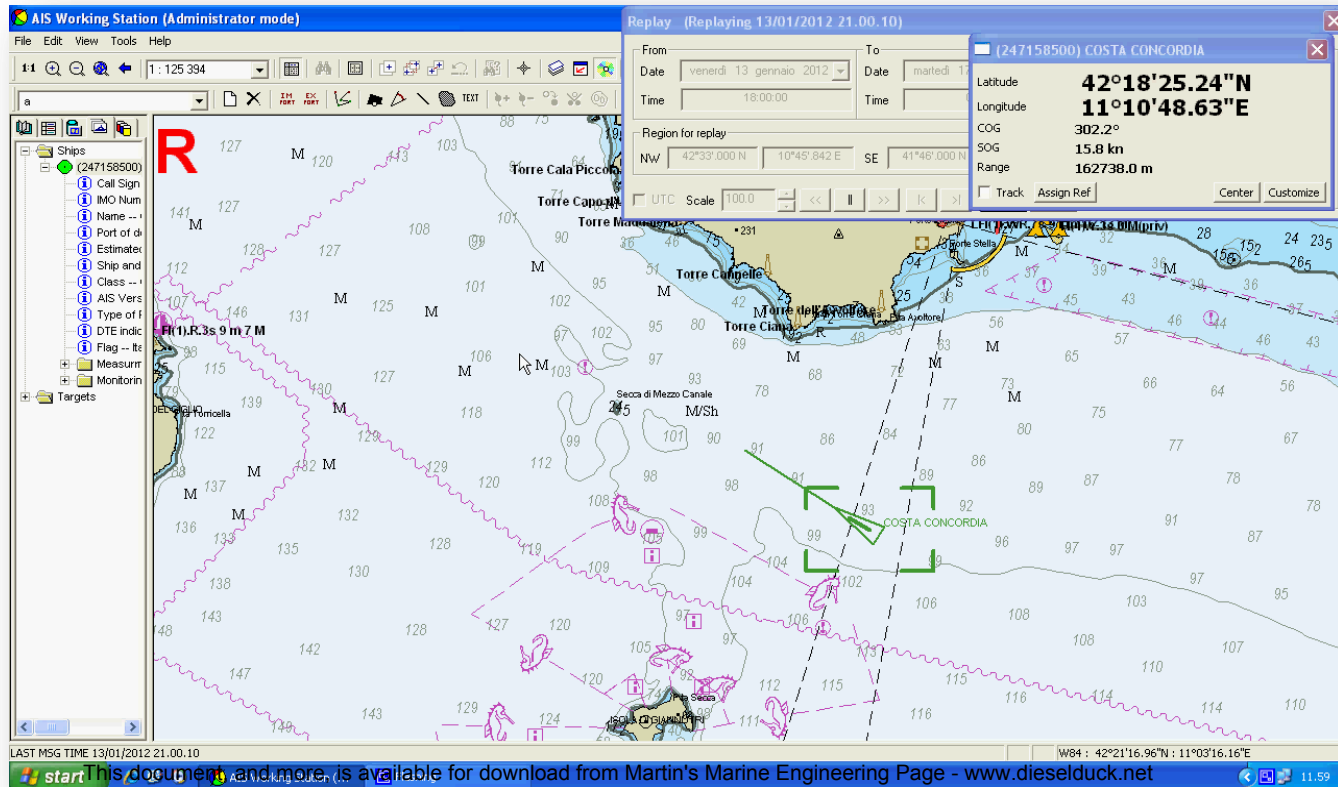
Ship's position at 09.00 pm according to the *Automatic Identification System (AIS)*

- Coordinates: Lat 42°18'25"N - Lon 011°10'48"E
- Bearing of 230° Punta Secca - Island of Giannutri
- Distance: 4,2 miles
- True course: 302°
- Speed: 15.8 knots

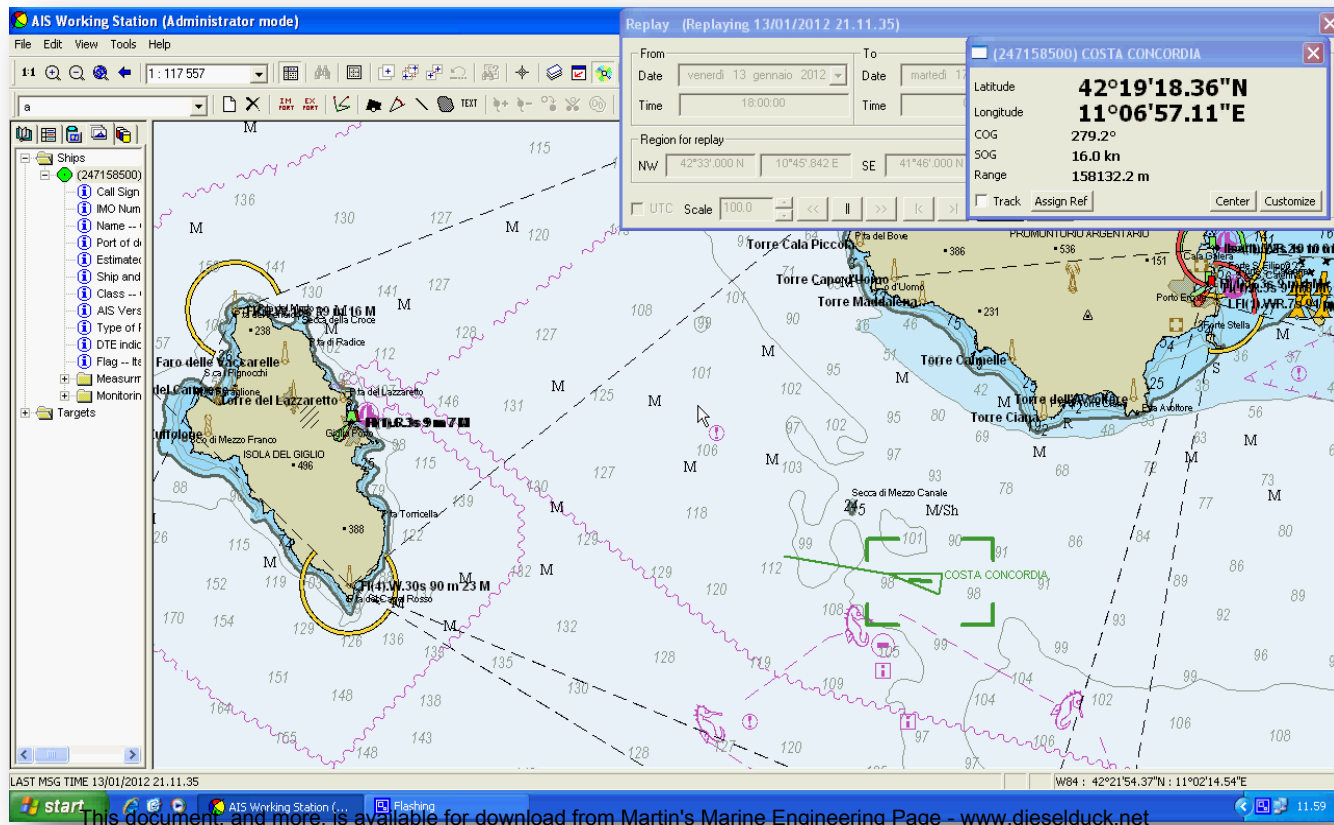
09.03 pm

the Ship starts attending to port until 09.11 pm, when she gets to a position of

- Coordinates:  $42^{\circ}19'18''\text{N}$  -  $011^{\circ}06'57''\text{E}$  ;
- Heading of  $279^{\circ}$ ,
- Speed: 16 knots;
- Heading towards the Island of Giglio.

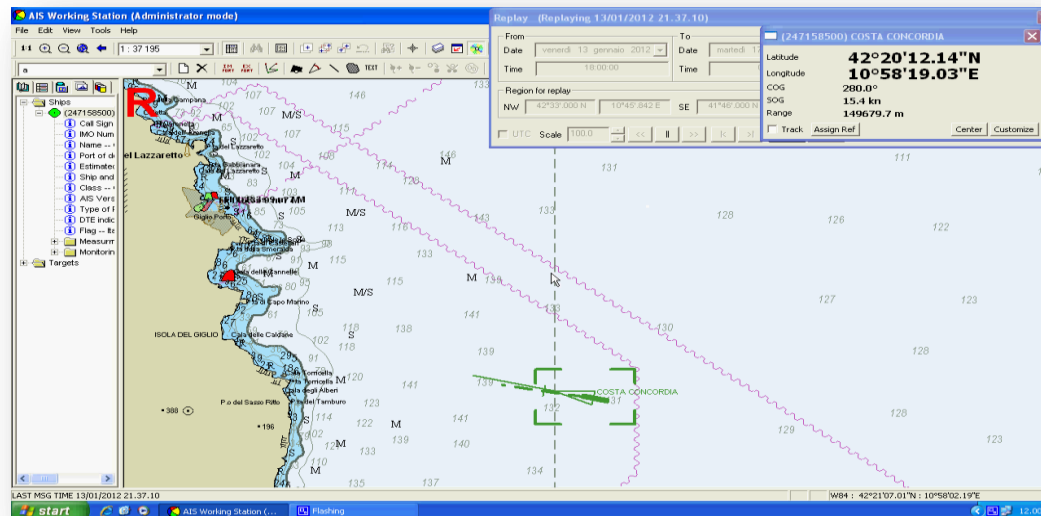
**At 09.37 pm** : Ship's position is  $42^{\circ}20'12''\text{N}$  ;  $010^{\circ}58'19''\text{E}$  (about 1,8 mile East Punta della Torricella - Island of Giglio), at a speed of 15.4 knots.

She turns to starboard in order to make the safety passage close to the Island.

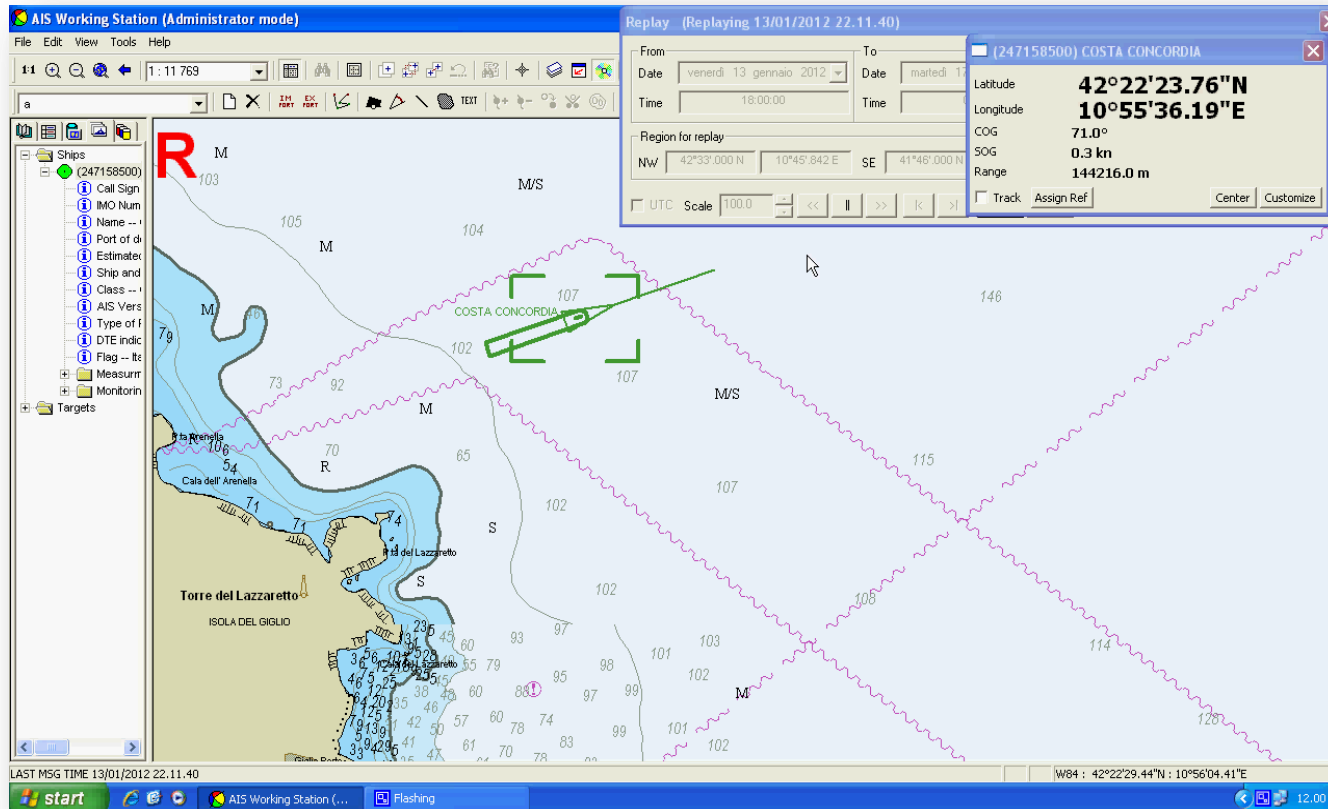
At 10.12 pm

- detects the Ship in proximity of the Island of Giglio (Punta Lazzaretto).
- tries to contact the Ship. Someone onboard (unknown identity) informs about the black out onboard.

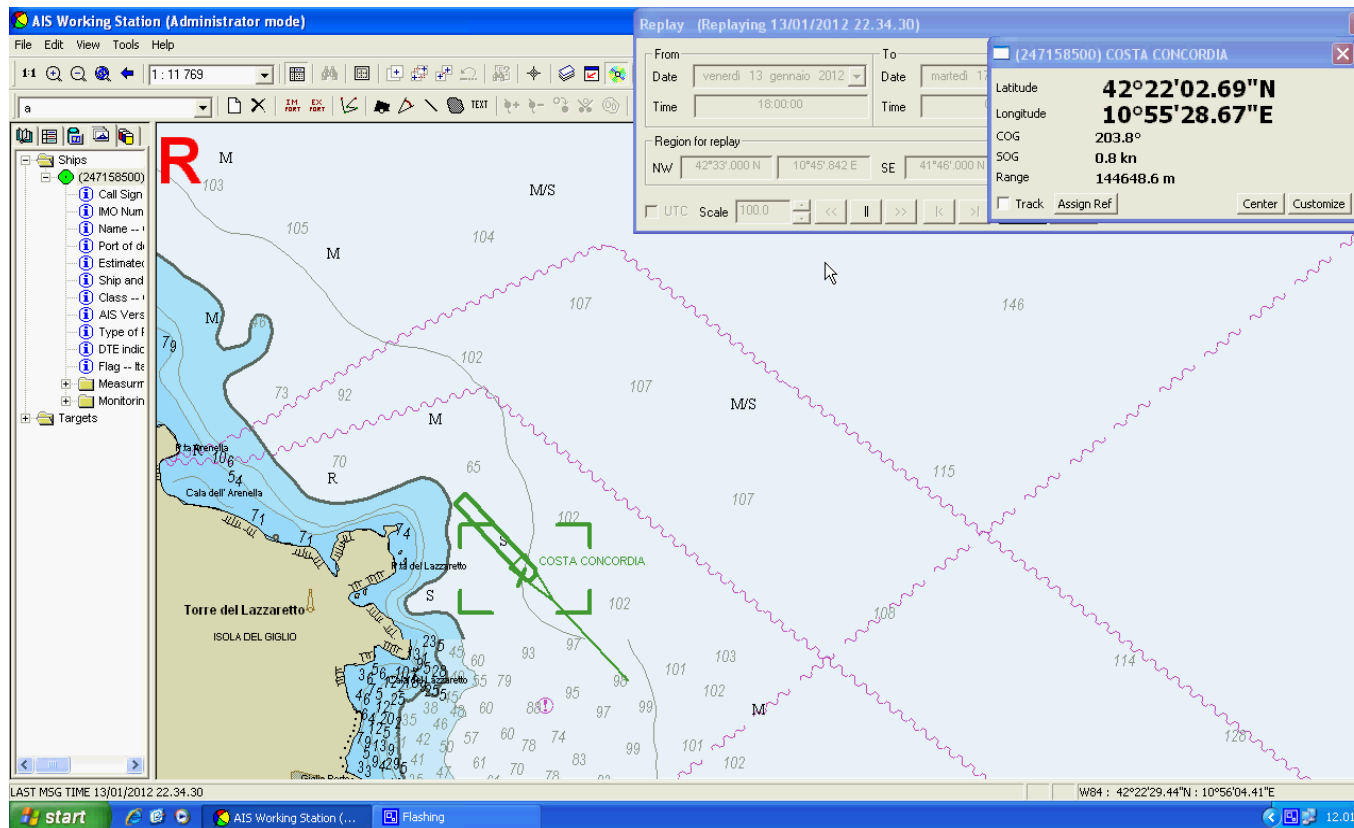
At 10.34 pm

The ship reports that the heeling is increasing and declares the “**DISTRESS**”

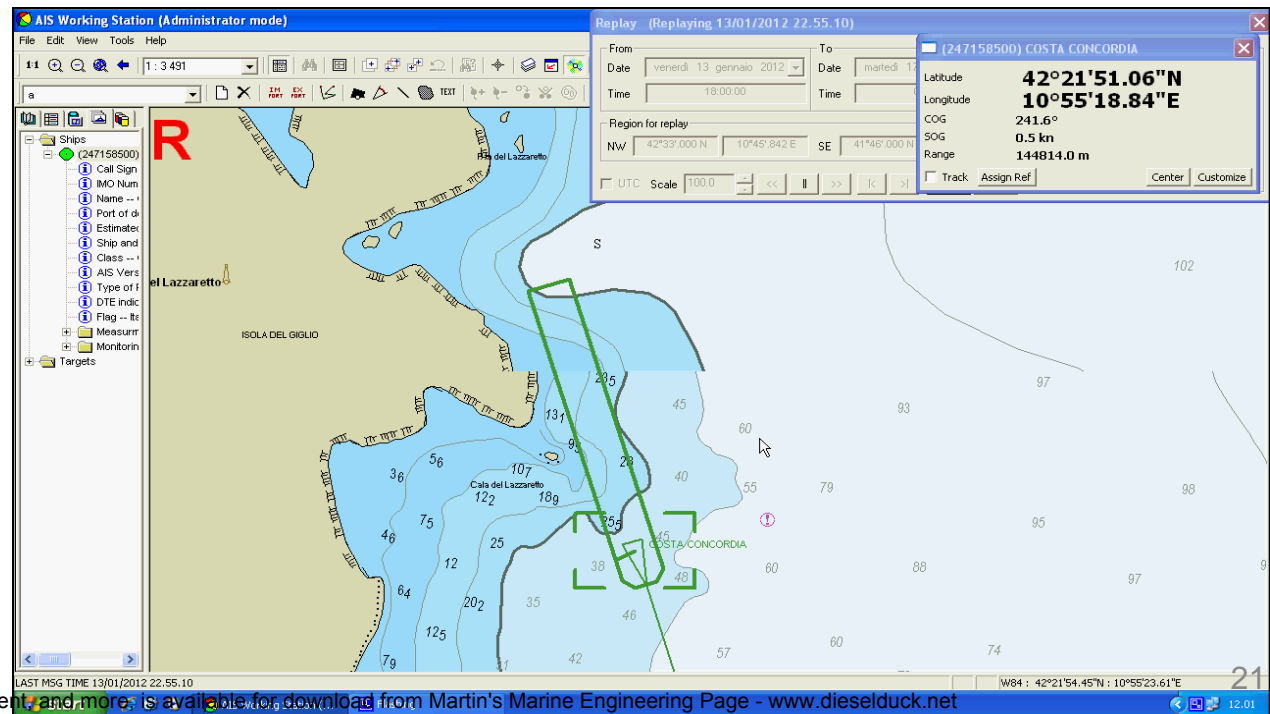
“Patrol boat G 104” (designated O.S.C. – On Scene Commander), being alongside the ship, informs Leghorn M.R.S.C. about the Ship’s stern heaviness, and at 10.44 pm she is laying on her starboard;

**At 10.40 pm (09.40 pm UTC)**

the Ship launches the distress through INMARSAT “C” (1530 – 75 tracks).

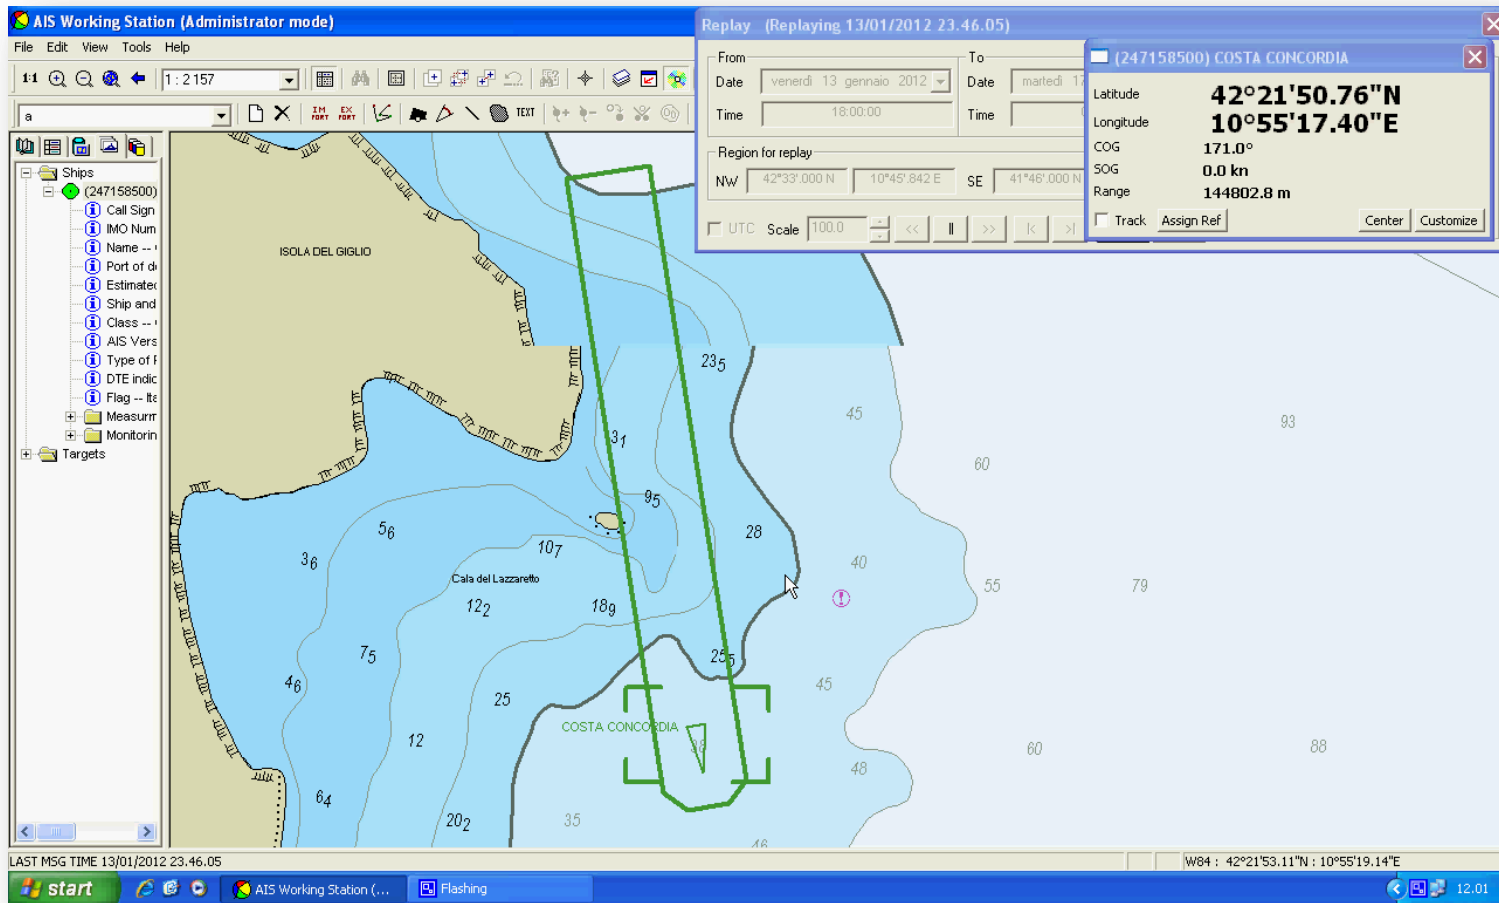
### SHIP'S LAST POSITION

- **01.46 am:** Leghorn M.R.S.C intimates the Ship Master to go onboard the Ship and to give an account of the actual situation
- **03.44 am :** 40-50 persons at least are onboard
- **04.22 am :** 30 persons are still onboard
- **04.39 am:** On Leghorn M.R.S.C. request, the “Patrol boat G.104” reports the ship’s position -  $42^{\circ}21'.36N$   $010^{\circ}55'.12E$ , laying on a 27 meters bottom

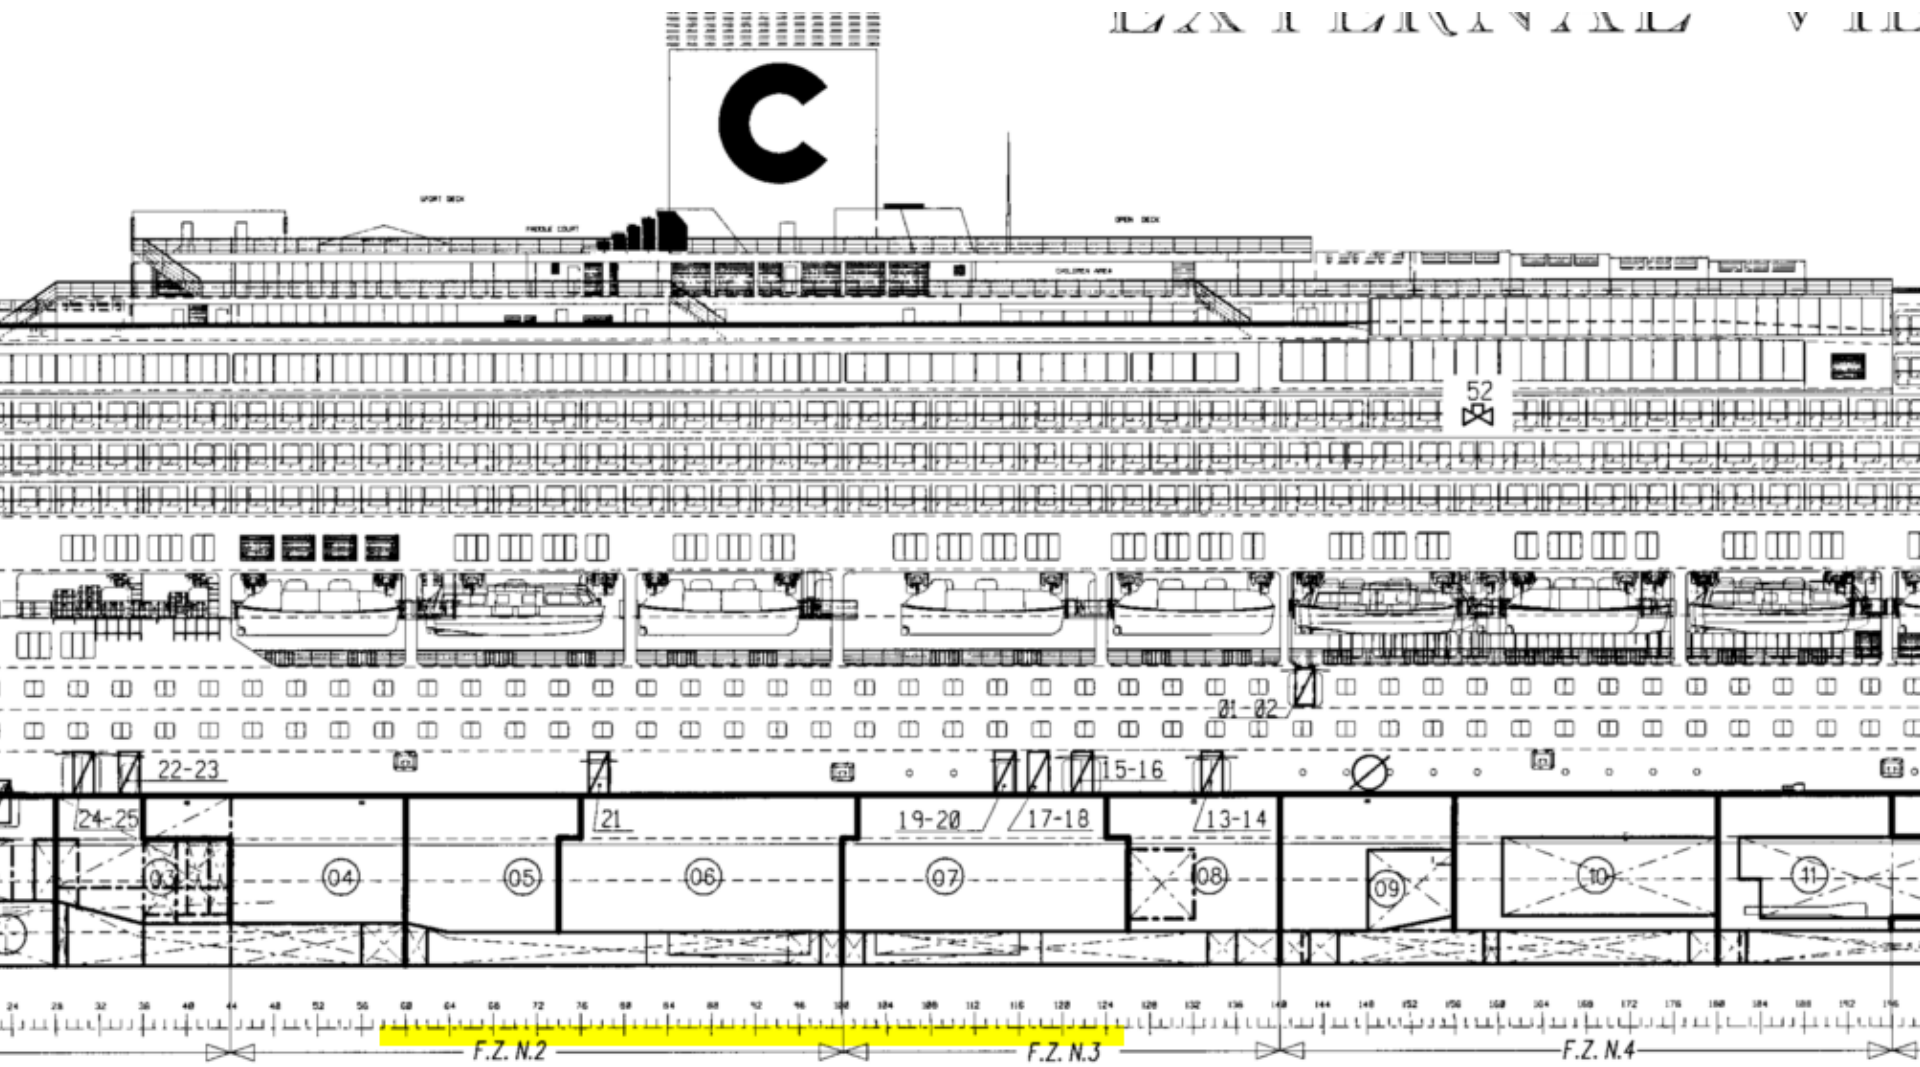
**Damage between frame no. 58 and frame no. 125/128,  
creating a 60 meters hole into the hull – portside**

- **The two most affected watertight compartments (contiguous), immediately flooded:**
  - no. 5 (Propulsion Electric Motor)
  - no. 6 (aft generators)
- **Partially flooded at the time of crew inspection (10 minutes after the impact)**
  - no. 7 (forward generators)
  - no. 4 (Galley compressors)
