Cruise liner accident highlights many problems including with emergency power generation

Costa Concordia capsizes

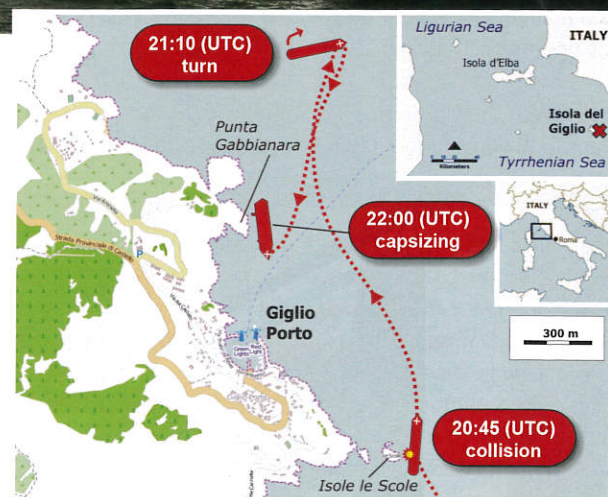
It has been concluded that the ship was sailing too close to the coastline, in a poorly lit shore area, under the master's command who had planned to pass at an unsafe distance at night and at high speed (15.5kts). The danger this entailed was recognised too late to avoid the impact which was so severe that the ship heeled over and its speed rapidly decreased – from 15.3kts at the moment of impact on the rocks down to just 3.9kts in a little over six minutes.

The vessel immediately lost all propulsion and was thus affected by a blackout. Although the emergency genset cut in as expected, it was unable to supply the utilities to handle the emergency and only operated on and off. The rudder remained jammed to starboard, turning the vessel in that direction and resulting in it finally grounding on Giglio Island at around 23.00 with a heel of approximately 15°.

A map showing the track of the vessel from hitting the rocks till it capsized
