## Tips for the operator

Extracts from ABB Turbocharging's  
Turbo Magazine 1990 – 2007

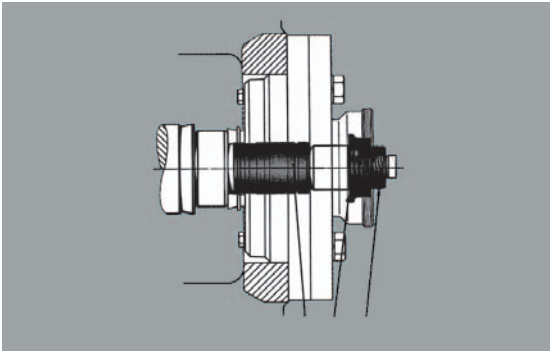
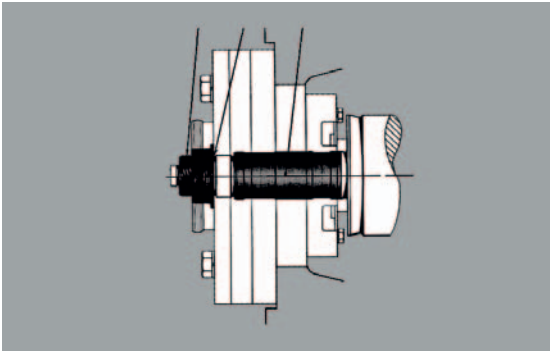
To avoid fretting, always apply white  $\text{MoS}_2$  lubricating paste (e.g. "Molycote D or DX") to the thread at the end of the shaft, to the bearing journals and to the front contact surface of the ring nut.

Coat with Molycote D or DX

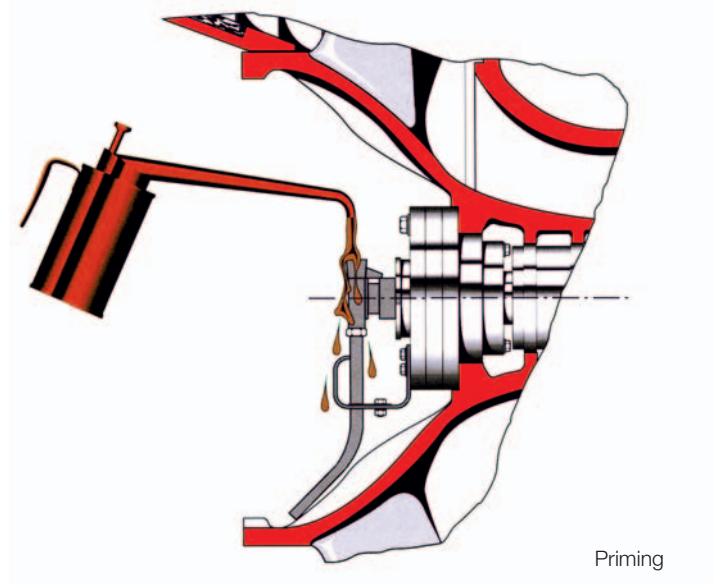
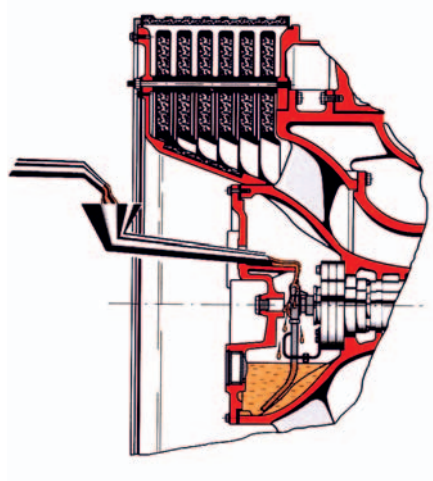
To function properly, the pumps body must always be filled with lubeoil. Therefore, before a pump is fitted to the turbocharger it must be primed before the bearing cover is fitted (*see picture on the right*).

When refilling with lubeoil, also make sure that the oil flows over the pump head. Special attention must be paid when using extension pipes or hoses in order not to push them too far inside.

Correct

We also recommend that gear oil pumps be checked for tightness and proper functioning every 16,000 running hours in one of our service stations.

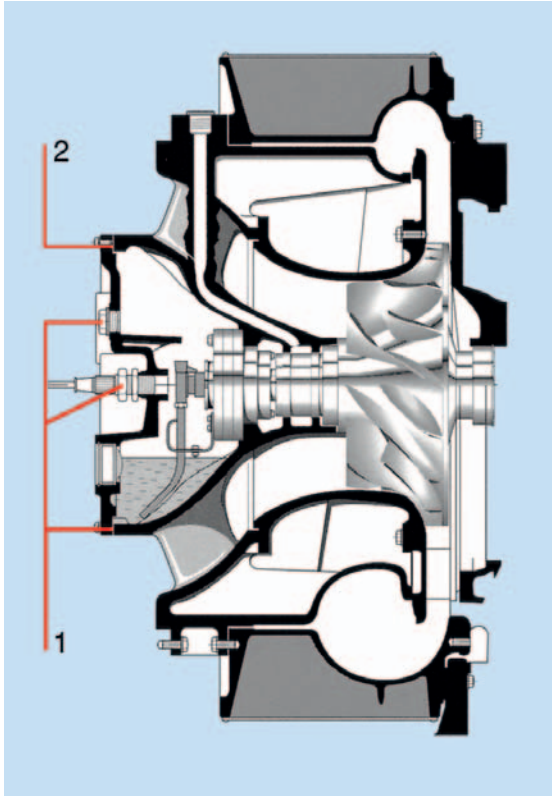
Reports are received from time to time about a sudden oil loss in the oil chamber on the compressor side. Investigations invariably show that this occurs either after removal of the oil space cover during a bearing change, after an oil change, or after speed control by means of the manual indicator.

The reason for the oil loss is easily explained. During normal running there is a slight underpressure in the oil chamber on the compressor side. If there is a leakage due to the plugs (1) not being properly tightened, or if a damaged gasket (2) is reused, the underpressure will not be maintained. Instead, there will be a flow of air from this leakage to the compressor wheel. This air flow entrains oil from the oil chamber, leading to the oil loss. We would therefore like to call your attention to the following: Before mounting the oil space cover, check the condition of the gasket. If there is any damage at all or you are in doubt about it, replace it. Also, after changing the oil tighten the plugs properly and make sure that a gasket is fitted. And when using the manual indicator for speed control, refit the respective plug without any long delay. If the gauge glass is damaged, replace it as soon as possible.

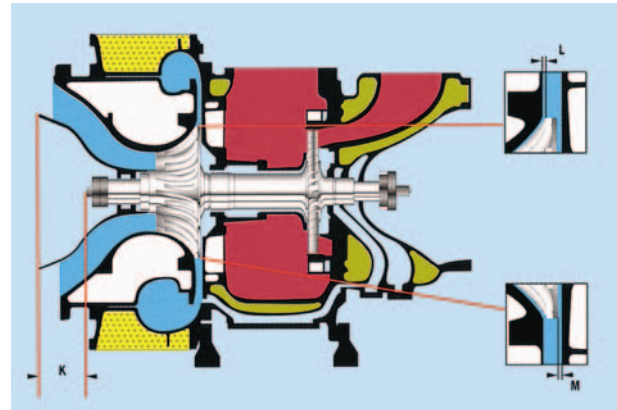
Fig. 1

- Measure dimension K (see Fig. 1).
- Withdraw bearing about 5 – 6 mm.
- Push the rotor towards the compressor.
- Measure dimension K1 (see Fig. 2).
- Pull the rotor towards the turbine.
- Measure dimension K2 (see Fig. 3).

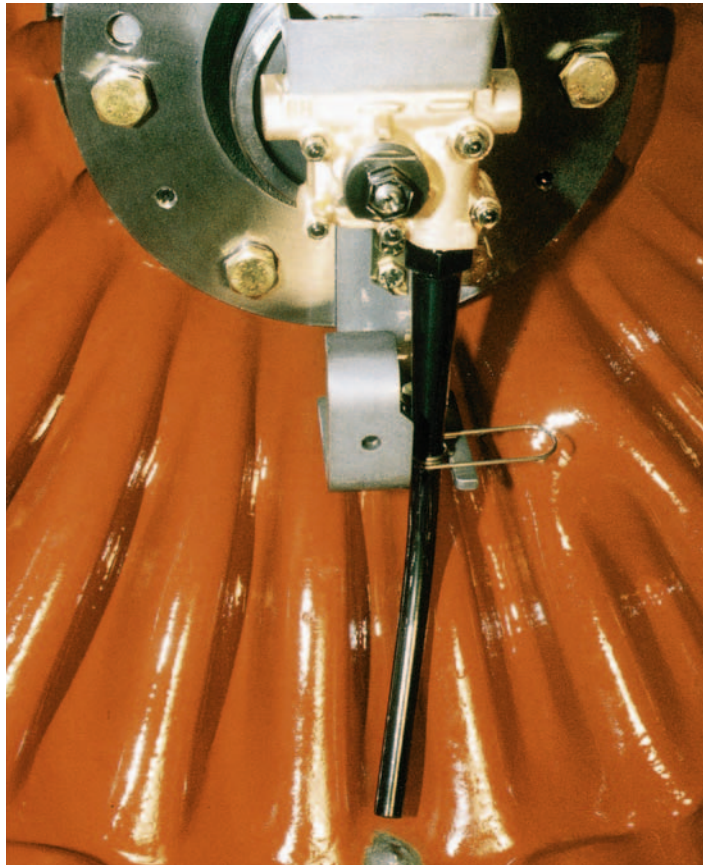
A small cone-shaped accumulation of sludge and oil-aging residues, mixed with abrasion particles of steel, aluminum and bronze originating from the casing, pump and bearing damping parts, often forms just below the opening of the gear oil pump suction pipe. The residues accumulate at just this spot due to the suction flow current of the working gear oil pump. Most particles just remain there, but some are sucked through the pump and injected into the centrifuge, which also works as a dirt separator, where they are finally collected and can be removed during a standard overhaul.

The residues are harmless and have no negative influence on safety or running behavior. No measures need to be taken to reduce or restrict their formation.

Such a sludge/particle mixture can grow to approximately  $\frac{1}{4}$  of a  $\text{cm}^3$ . Its size will depend on the following:

- Level of vibration
- Newly installed parts
- Cleanness of the oil chamber
- Purity and quality of the lube oil
- Number of running hours

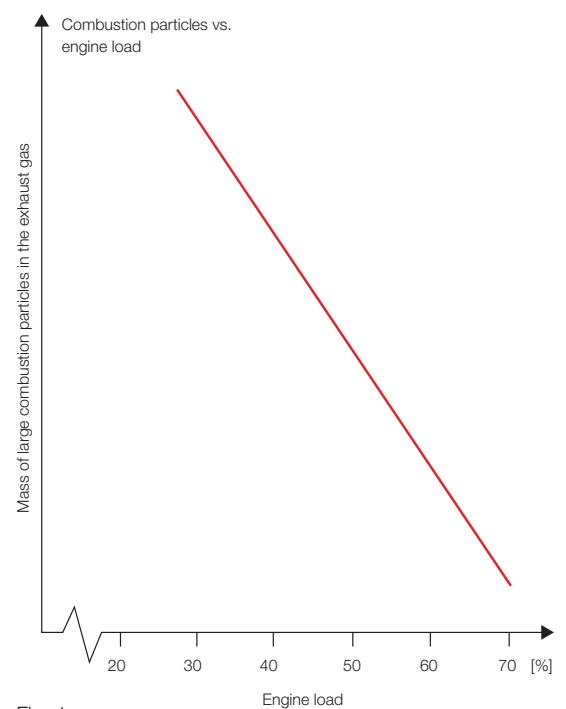
Fig. 1

Also significant are the fuel oil preheating, compression ratio, injection equipment wear and engine load. The engine part load, in particular, plays a major role in the formation of the larger particles causing erosion (see figure).

- Start by ensuring that your engine is top fit.
- Have a fuel oil analysis performed by a noted laboratory. This will help you to avoid fuels with inferior properties.
- If you are running more than one generator or auxiliary engine, avoid running them for prolonged periods at low loads (*Fig. 1*). If possible, run fewer generators at higher loads.

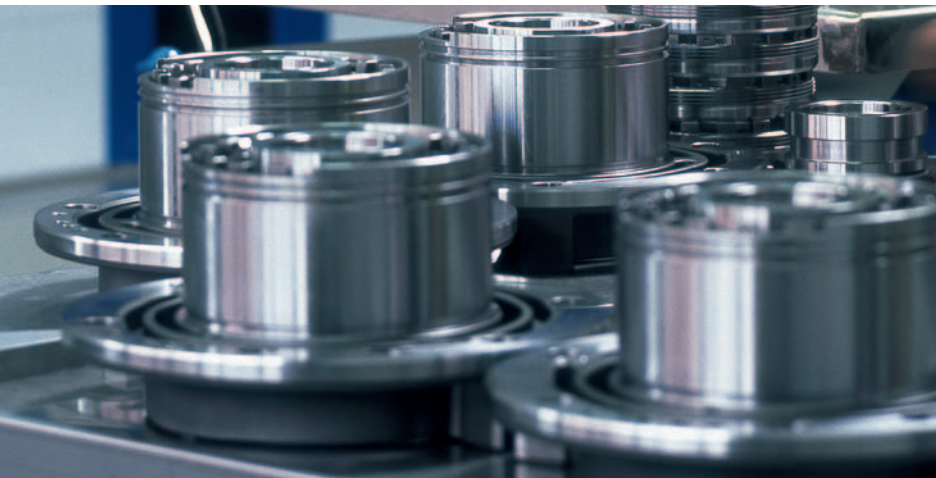
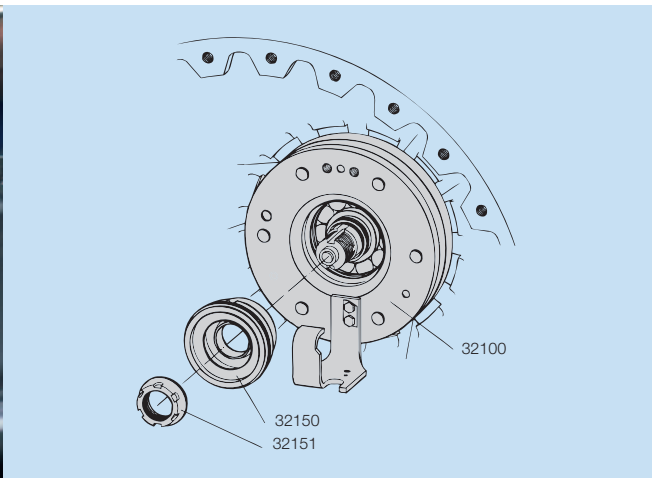
We have found in the past that when installing bearings, some customers use the hex.-head screws to push the bearings into position. This practice causes damage to the bearings and may even result in breakdowns!

To correctly install the bearings, follow the steps below. For more details, see chapter 5 of the operation manual “Disassembly and Assembly”.

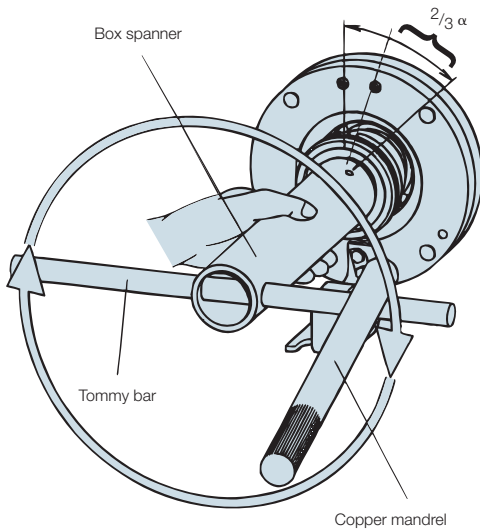
VTR 454 - 714

Experience with the VTR 454-714 has shown that a tightening angle equal to  $\frac{2}{3}$  of the angle of rotation  $\alpha$  is sufficient when tightening the shaft-end nut at the turbine end. When tightening, use the copper mandrel (90048) as the striking tool.

- Position the box spanner and make a mark on the centrifuge in the radial extension of the "O" mark (*see sketch*).
- Tighten the shaft-end nut by striking the tommy bar with the copper mandrel until  $\frac{2}{3}$  of the second mark on the box spanner coincides with the mark on the centrifuge.

Note: To ensure more concentric running, turn the rotor  $180^\circ$  with the box spanner and ring nut between each blow with the mandrel.

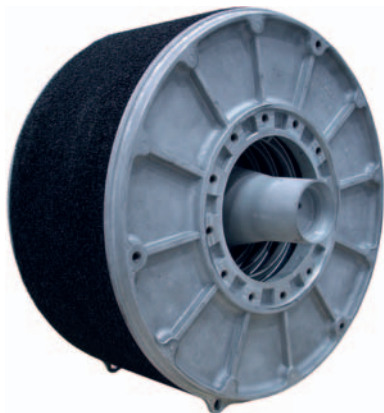
Field experience has shown that when disassembling and assembling the silencers (PN81100) fitted to the VTC..4, the cast-aluminum cone of the front funnel is susceptible to damage if incorrectly handled. This can lead to the cone breaking away during operation, causing turbocharger failure.

Extreme caution should therefore be taken when disassembling and assembling the silencer to ensure that the silencer does not strike the cone area of the aluminum front funnel. When removed from the turbocharger, the filter silencer must not be allowed to rest on the cone of the silencer. It should also be suitably protected when stored or in transit. If it is thought that the cone area may have been struck or damaged, it is recommended that a dye penetrate crack inspection be carried out before it is returned to service. When replacing the silencer, care must be taken to avoid contact with the compressor. In the event of the compressor being struck, the silencer should be removed and inspected for cracks. If there are signs of cracks the front funnel has to be replaced.

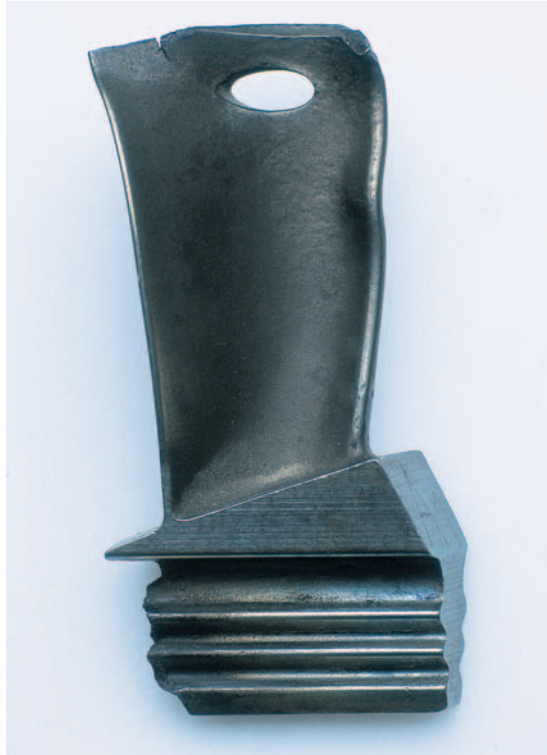
Signs of the following damage on a turbo-charger could indicate a problem with the protection sleeves in the compensators. If they start to break away, they could damage the blades as shown. To avoid further damage, please check all of the compensators (it will be necessary to balance the rotor). Please contact your nearest Service Center.

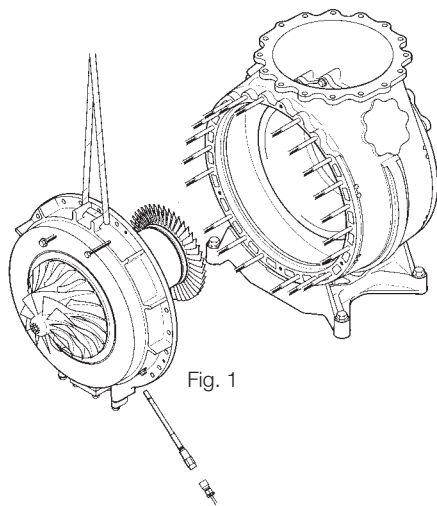
Fig. 1

Did you know that the turbocharger could be blanked off without affecting the power more than is absolutely necessary? For example, with our new TPL turbocharger, the cartridge group (rotor block, Fig. 1) can be removed and the open gas outlet casing closed with a blanking cover (Fig. 2). This will allow the engine to at least be used – with a lower power – until the next repair opportunity arises.
